Cobb Dam Sinkholes

Bruce Walpole¹, Craig Scott²

TrustPower Ltd¹
Riley Consultants Ltd²

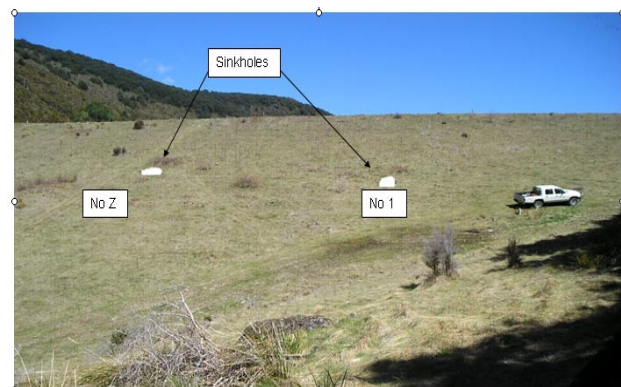
Figure 4. Location of sinkholes (note: route march sample point below truck)

During the 2006/07 annual civil inspection staff noticed two significant sink holes on the downstream face of the dam wall (Fig. 4). The discovery was made during a walkover of the face of the dam, and although the local route march took staff relatively close to (10-15m) the depressions during routine

monitoring rounds, the angle of the slope and grass cover contributed to these sinkholes lying unnoticed until the annual civil inspection was undertaken. These sinkholes were shallow depressions, approximately 2.5 m square and less than 1 m deep (Fig. 5). The sinkholes were located approximately one third of the way down the dam face with one approx central and the second toward the left abutment.

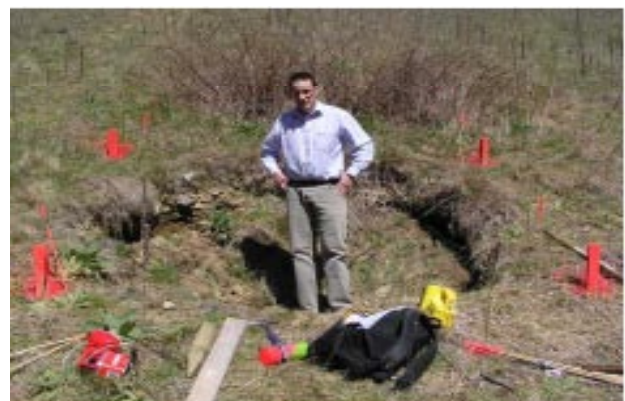
Figure 5. Sinkhole size and depth at the surface.

The sinkholes were nearly square depressions which had occurred relatively recently. One sinkhole had sufficient exposure for a small plant to establish itself on the vertical exposed scarp feature while the other sinkhole scarp was bare and fresh. The sinkholes were approx 30 cm deep and 2-2.5 m wide (Fig. 5). The edges had holes running into them 30 cm in depth. Long grass in places formed a mat over the failed zone. No water was present in or exiting the depressions.

It was judged that at this stage there was no indication of accelerating deterioration, seepage from the dam face or any other typical piping failure type indicator, aside from the surface settlement.

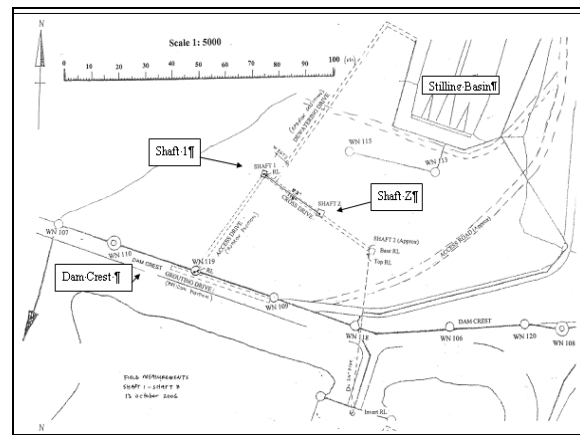
Figure 6. Location of shafts and sinkholes.

The access drives and drainage tunnel drawings provided the most compelling evidence that the sinkholes were due to shaft backfill material settlement, and not a safety issue leading to a potential dam failure. Two construction shafts were shown to be in the near vicinity of the sinkholes and the size of the sinkholes matched shaft details.

Shaft 1 (Fig. 6) was excavated in December 1944 to explore the underlying rock conditions on the true-left of the Cobb River. The shaft was 6' 6" by 3' 4" and was timber lined. A cross-drive was excavated beneath the Cobb River to connect this shaft with shaft 2. Fisher (1946) provides a detailed account of the geological and geophysical excavations undertaken until October 1946.

Shaft 1 extends from the ground surface to the cross-drive 30 m below. The shaft passes through the embankment fill (Class A downstream shoulder and Class G drainage material), and through in situ material consisting of moraine and river gravels. The blanket drain (Class G) was placed directly on the prepared dam foundation at a slope of 3.25:1.

Shaft 1 was due to be backfilled with Class F material after the completion of the foundation grouting but was left open until the end of construction as access for lining the cross-drive. Upon completion of the fill embankment, the base of shaft 1 in the cross-drive was to be filled with a concrete plug and the shaft backfilled with Class H material with compaction and the top 10' to 15' of timbering removed.

Shaft Z was excavated as part of the earth dam drainage system, with four 3 inch diameter holes drilled at the top of the cross-drive to allow water to exit. This shaft was 8 ft by 8 ft and timber lined.

Construction photographs show shaft Z with timber shoring exiting the compacted earth. The photographs show the material surrounding the shaft being compacted. However it is possible that this material was not compacted to the same standard leaving some areas potentially erodible, or subject to differential settlement. Shaft Z was backfilled as for shaft 1.

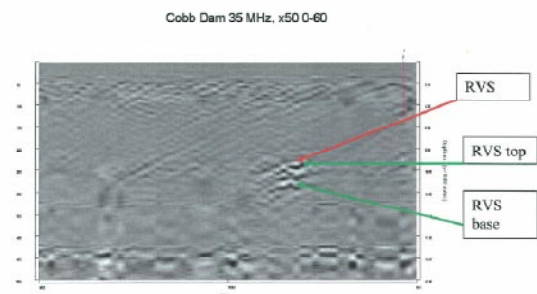
Figure 7. GPR data example of radar void signature approx 2-2.8m high

The geophysical survey identified the presence of possible large voids in or around shafts 1 and Z (Fig. 7).

These void targets have been interpreted as either indicating the presence of dry granular material in the shafts, or the presence of air voids. Ongoing discussions with Subsurface Imaging Ltd have confirmed that the most likely interpretation of the target signatures is that they are consistent with air voids.

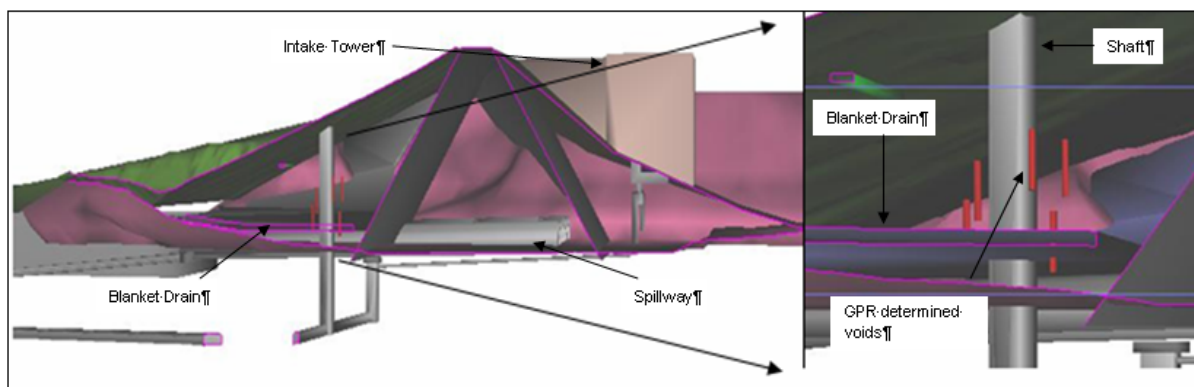
Figure 8. 3D model of dam cross section with close up view of GPR determined voids (red zones)

A 3-D model of the dam structures and zoning was developed to help interpret the relationship of these targets with in situ material (Fig. 8). The targets all cluster around the shafts generally above the level of the blanket drain.

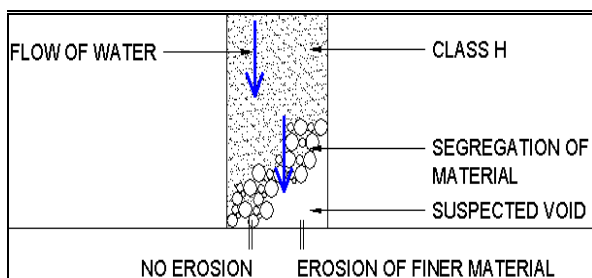
Figure 9. Schematic of Shaft Z showing segregation of material and loss of fines.

Characteristics of the Class H material in the shafts suggest that this material is segregated. The maximum particle size of 150 mm, the low percentage of sand and fine gravels (25% finer than 4.75 mm), and the probable end-dumping from trucks and high lift heights are all typical precursors of segregated soils. Segregation of material may also have contributed to the internal movement of fine material, which has undoubtedly occurred as evident from a post-construction note from the site office to the Hydro Design office in Wellington about the need for monitoring discharge (of stones and muddy water) from the drainage holes in shaft Z (Cowie 1957).

The water in shaft Z drains to the cross-drive through four 3 inch holes. An inspection of these holes was undertaken during the site inspections and found that the first hole was blocked and the second hole had water seeping out. A long crowbar was inserted into the third hole with no resistance, indicating a large void immediately above the cross-drive, and when it was inserted into the fourth hole a small amount of fine gravel came out.

The void in shaft Z above the cross-drive was probably caused by the movement or removal of Class H material by water exiting the drain holes. It is inferred that, due to the probable segregation of the material, the finer fraction has been washed out of the drainage holes into the cross-drive until it has re-sealed. Prodding the material as discussed above induces flow of water and sediment through the holes. Arching of segregated large gravel has likely created a void above the cross-drive (Fig. 9).

- CCTV inspection of drain holes in shaft Z to determine if the segregation and erosion cavities in the shaft base exist.
- Test pit sampling of the shaft backfill and crest materials to determine gradings and compatibility with surrounding materials.
- Installation of deformation survey markers to monitor settlement at the shafts.
- Commissioning of turbidity monitoring.
- Full geotechnical and geological data acquisition for the dam site.
- Dam zoning compatibility assessment and identification of key areas of risk.
- Dam stability assessment.

- Enhanced Monitoring.
- Injection grouting of voids and shaft material.
- Forced settlement of material.
- Remove and replace shaft material.
- Replace surface material and level to adjoining surroundings.

The present consensus is that increased surveillance is appropriate at this time, as the inferred risks associated with the various other options are considered to outweigh the benefits until the cause of the settlement and exact nature of potential voids is determined. A comprehensive risk assessment has been proposed for the dam to test this option.
