Geological Inputs into the Waipori Dams Stability Review

L A King
Riley Consultants Ltd, Christchurch, NZ
lking@riley.co.nz

T Fritz
Trustpower Ltd, Tauranga, NZ
thomas.fritz@trustpower.co.nz

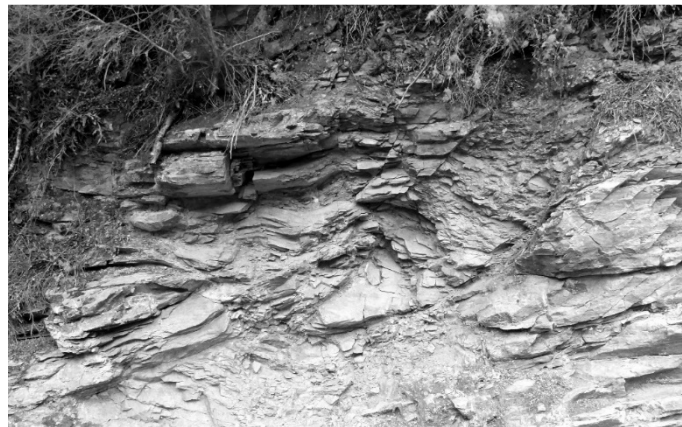
On the left abutment of the dam, the schist is of good quality, moderately weathered, moderately strong with quartz segregations up to 50 mm thick, though typically less than 20 mm. Foliation attitude on the left abutment dips 20 to 30 degrees to east to north-east. By contrast, the right abutment is highly disturbed with numerous shear zones present, varying in character but with distinctly fissile rock mass sheared to fine to coarse, platy, angular gravel. Foliation orientation within shear zones is variable though broadly parallel to sub-parallel with the orientation of the McNamara Fault, with micro-folds (Figure 1) evident within some zones. The disturbed nature of bedrock on the right abutment is attributed to the proximity of the McNamara Fault which was mapped (MacFarlane 1986) as passing approximately 200 m to the south of the dam. Recently a new track has been cut on the river right of the No.4 reservoir, which exposes the fault. The zone of deformation is approximately 70 m in width at this location (consistent with the earlier DSIR report), highly disturbed, with a lack of distinct fabric. Material in the fault zone is predominantly extremely weak and when logged as a soil material is assessed to be moderately dense, light greyish brown sandy angular gravel. There are zones (up to 2 m diameter) of dark bluish-grey, highly plastic silty clay within localised pockets within the overall fault zone. Shear and crushed zones were noted up to 300 m on either side of the 70 m wide fault zone, including on the right abutment of the No.4 Dam. The fault appears to be high angle and downthrown on the southern side, indicative of a reverse thrust fault.

Figure 1: Micro-folds within shear zones in Haast Schist at No.4 Dam

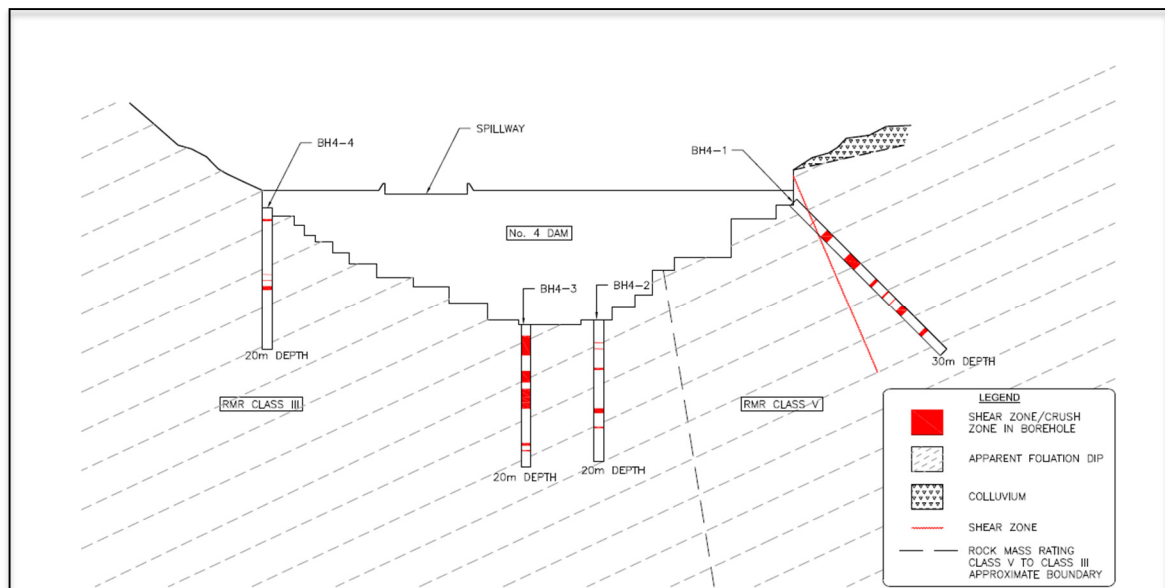
Figure 3: Cross Section of No.4 Dam showing encountered shear/crush zones.

Many crushed and sheared zones were noted on the borehole logs as shown in Figure 3. While it is possible that shear zones could daylight in the dam foundation (as proposed by MacFarlane 1986), in light of the recent investigation it was considered unlikely that one large crush or fault zone exists within the dam foundation, rather a number of smaller shears likely attributed to the proximity of the McNamara Fault.

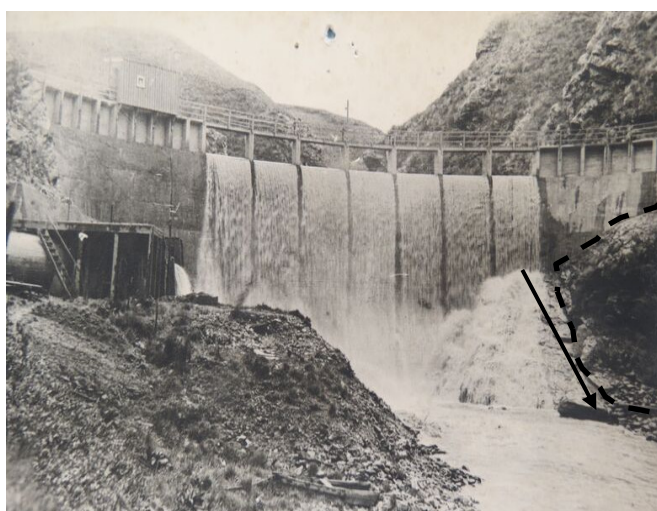
A potential sliding failure mechanism was identified for the left abutment of the No.2 Dam. Historical photos of No.2 dam shows there does not appear to have been movement on this abutment since completion of construction (Figure 4a), however, it is noted that since raising the dam, water does now flow over the left abutment during dam overtopping events (Figure 4b). FEA analysis should assess the risk of block failure in this location and any impact this might have on abutment and dam stability.

Figure 4a: Historical photo of No.2 Dam, showing potential slide block, arrow indicates foliation plane and dashed line indicates potential block of instability (date unknown).

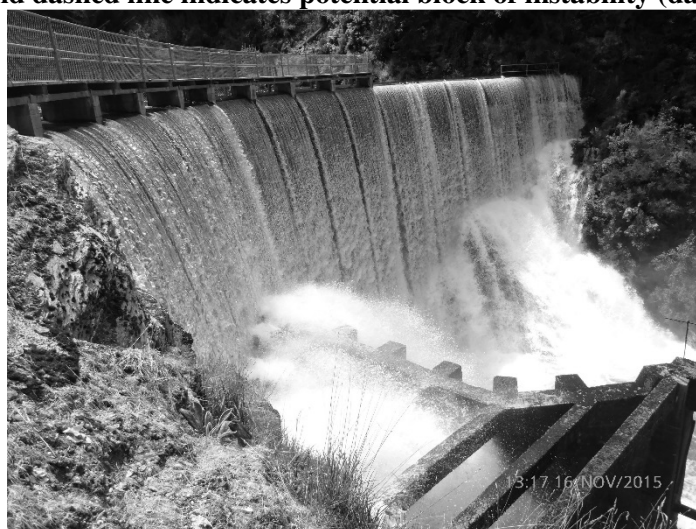
Figure 4b: Present day overtopping event at No.2 Dam (taken from downstream of right abutment, November 2015).
