Slope failure in complex volcanic terrain, Opito Bay, New Zealand

S.L. Price

Riley Consultants Ltd, Auckland, New Zealand

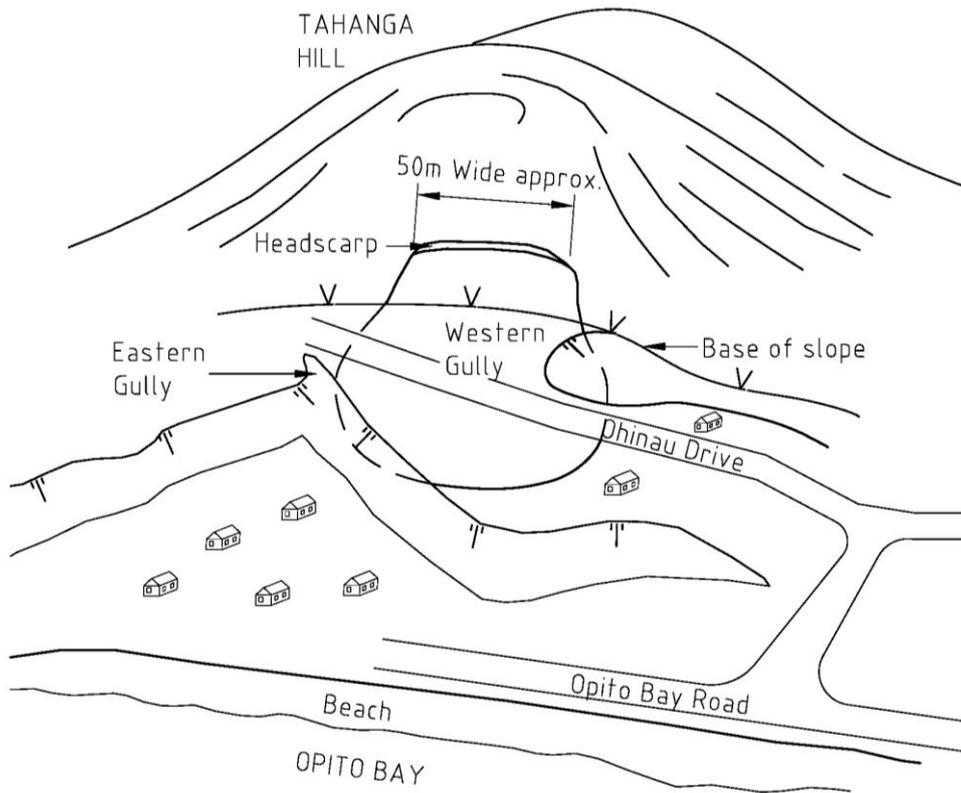
Figure 2

The Ohinau Drive slide is located at Opito Bay, north-eastern Coromandel Peninsula, New Zealand, as shown in Figure 1. The slope failure developed largely beneath vacant lots of a mid-1990s subdivision, extending southward into Tahanga Hill, as shown in Figure 2.

In 1996 significant ground movement occurred with a headscarp developed on sloping ground above the subdivision southern boundary. Ground heave was noted to the north within one of the lots, along with damage to services including the road, foot-paths and stormwater reticulation. Lot boundary pegs placed in 1993 suffered lateral movement by up to 0.5m. This movement followed a period of prolonged rainfall over several months, with up to 220mm of rain falling in less than a week.

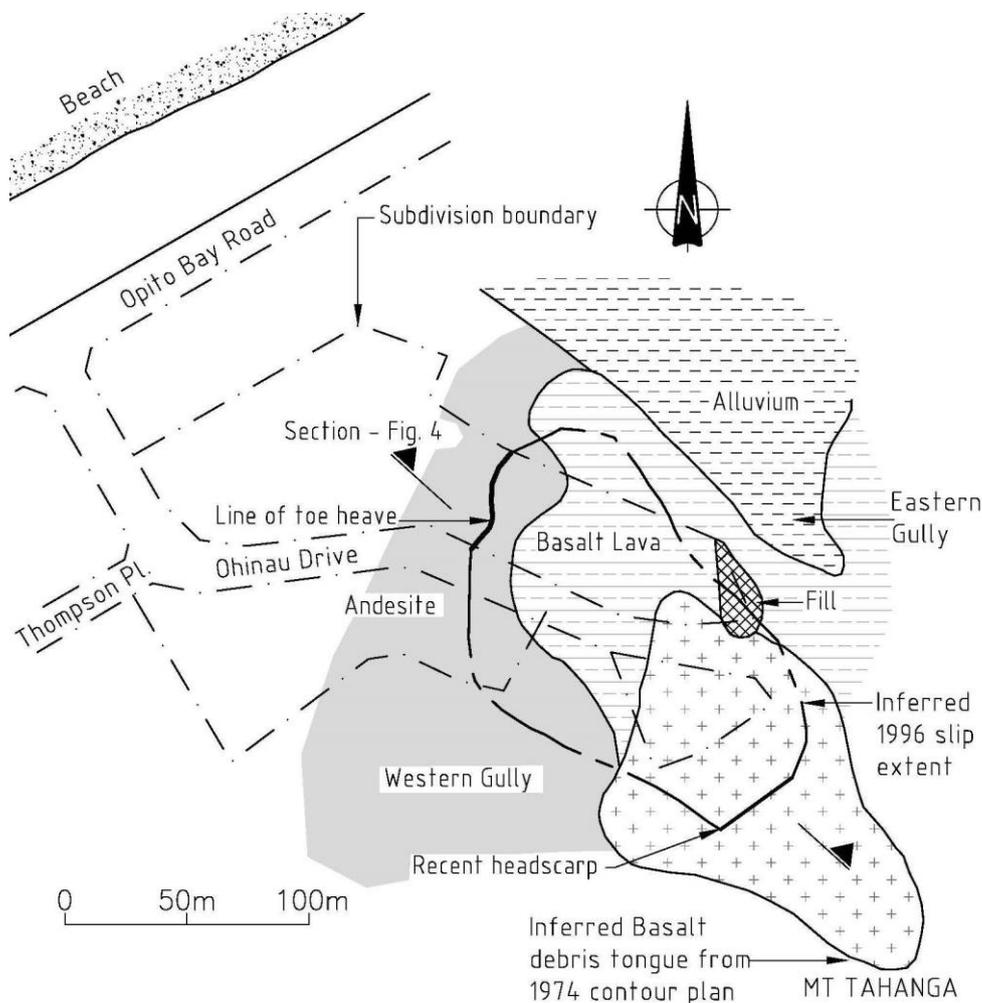
Figure 3

Brief descriptions of the main units are presented below with areal distribution shown in Figure 3:

- 1 Fill: Adjacent to the eastern gully, inferred remnants of a stockpile created during earthworks. Typically firm to very stiff silt, with topsoil layers.

- 2 Alluvium: Firm to very stiff silt, found beneath the fill within the eastern gully.
- 3 Basalt debris (colluvium): Basalt gravels, cobbles and boulders in a silt and clay matrix encountered to a depth of 11m at the base of Tahanga Hill and interpreted to extend beneath Ohinau Drive.

- 4 Weathered basalt lava: Highly weathered products of basalt lava flow, very stiff to hard soil inferred to be filling an ancient palaeovalley.
- 5 Weathered basalt tuff: Beneath the basalt debris to the east, this hard silt is inferred to be part of the original tuff ring that surrounded Mt Tahanga.

- 6 Lacustrine deposits: Typically comprising hard silt and clay, with layers micaceous and carbonaceous included rounded siliceous gravels. Upper horizon comprising mudstone, inferred to have been baked by andesite lava flow above. These deposits are inferred to be intercalated with the andesite and be in excess of 5m thick.

- 7 Hydrothermally altered andesite: Underlying the basalt and outcropping north of Ohinau Drive, the Mahinapua andesite varies from very stiff soil to weak rock strength, with varying degrees of hydrothermal alteration. In places the andesite appears sheared. Artesian water pressures were encountered in this material in 1997, underlying a portion of the slip mass.

- 8 Failure surfaces: Although not easily detected in recovered core, a distinct failure surface was encountered at the basaltic debris base where it contacts the underlying andesite consisting of a striated slickenside. A failure surface comprising clayey silt was also observed in a test pit excavated in the toe heave zone, with movement of hydrothermally altered andesite over similar residually weathered andesite. A failure surface, involved in the recent movement, is also inferred to have been encountered in the lacustrine deposits encountered in an older Worley borehole immediately below the basalt. Other potential failure surfaces were encountered in deeper lacustrine deposits, and these are inferred to have been possibly involved with past ancient movement.

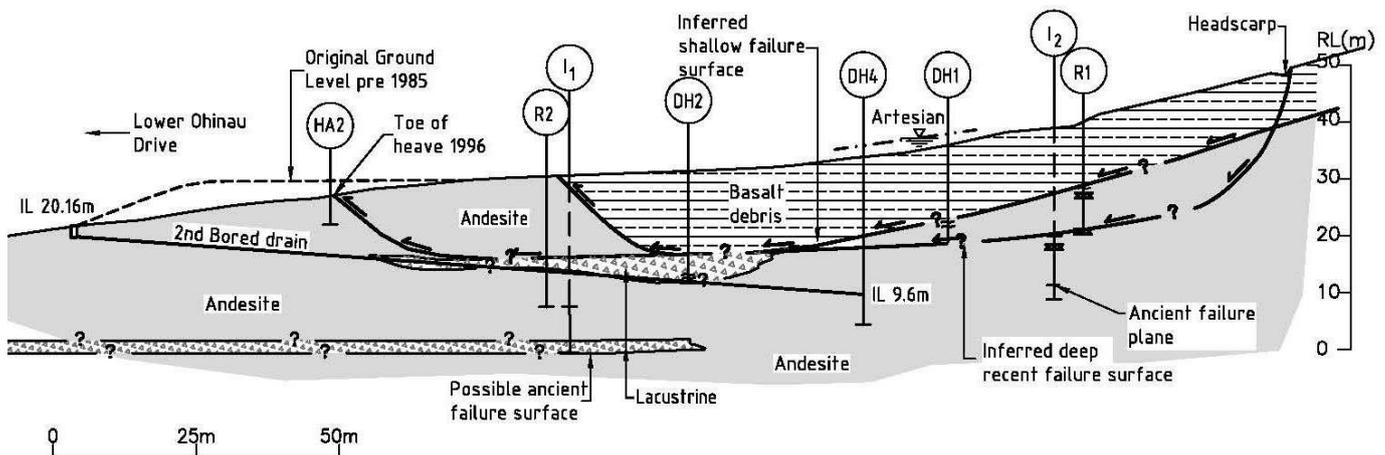
Figure 4

1 Surface debris failure: Reactivation of ancient slip debris moving over andesite to a depth of approximately 11m, which explains relatively large peg movements (in the order of 0.5m) in lots adjacent to Tahanga Hill. However, this failure does not explain the andesite toe heave north of Ohinau Drive, or the moving of boundary pegs in the western gully embedded in andesite.

2 Andesite failure: Deep failure in the andesite and also along planes in the lacustrine deposits, to a maximum depth of 20m. This failure mechanism is believed to have been active in the winter of 1996, is consistent with all the observed movement indicators, and is considered likely to be the primary cause of the observed damage.

Both failure mechanisms are shown in Figure 4.

Subsequent subsurface investigations in 2005 for the installation of further piezometers and inclinometers provided supporting evidence for the 1996 failure being deep-seated, occurring approximately 15m to 20m in the andesite and lacustrine deposits.
