# Cobb Dam sinkholes

Bruce Walpole <sup>1</sup> and Craig Scott <sup>2</sup>

<sup>1</sup> TrustPower Ltd, New Zealand

<sup>2</sup> Rileys Consultants Ltd, New Zealand

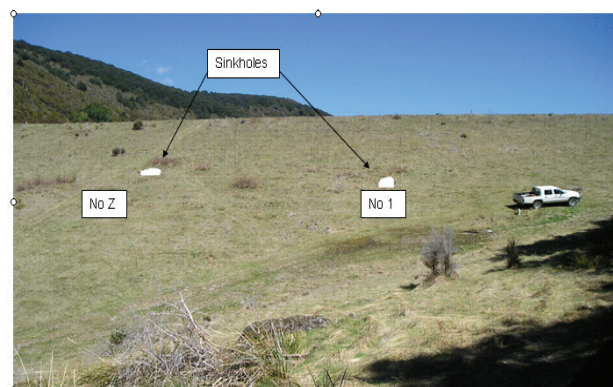
During the 2006/07 annual civil inspection staff noticed two significant sink holes on the downstream face of the dam wall (Fig. 4). The discovery was made during a walkover of the face of the dam, and although the local route march took staff relatively close to (10-15m) the depressions during routine

monitoring rounds, the angle of the slope and grass cover contributed to these sinkholes lying unnoticed until the annual civil inspection was undertaken. These sinkholes were shallow depressions, approximately 2.5 m square and less than 1 m deep (Fig. 5). The sinkholes were located approximately one third of the way down the dam face with one approx central and the second toward the left abutment.

**Figure 4. Location of sinkholes (note: route march sample point below truck)**

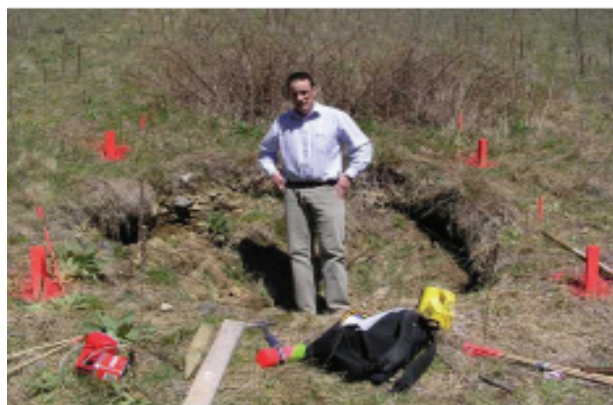
**Figure 5. Sinkhole size and depth at the surface.**

The sinkholes were nearly square depressions which had occurred relatively recently. One sinkhole had sufficient exposure for a small plant to establish itself on the vertical exposed scarp feature while the other sinkhole scarp was bare and fresh. The sinkholes were approx 30 cm deep and 2-2.5 m wide (Fig. 5). The edges had holes running into them 30 cm in depth. Long grass in places formed a mat over the failed zone. No water was present in or exiting the depressions.

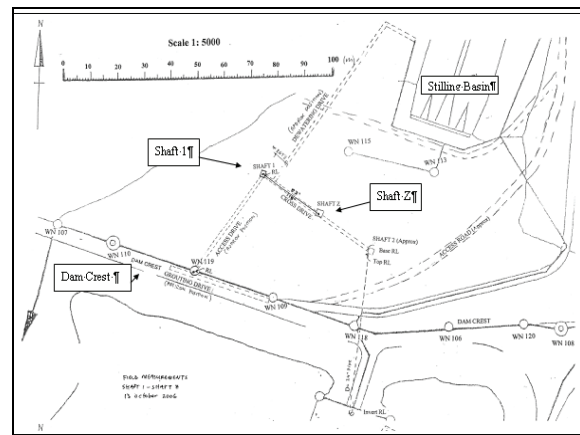
The access drives and drainage tunnel drawings provided the most compelling evidence that the sinkholes were due to shaft backfill material settlement, and not a safety issue leading to a potential dam failure. Two construction shafts were shown to be in the near vicinity of the sinkholes and the size of the sinkholes matched shaft details.

Shaft 1 (Fig. 6) was excavated in December 1944 to explore the underlying rock conditions on the true-left of the Cobb River. The shaft was 6' 6" by 3' 4" and was timber lined. A cross-drive was excavated beneath the Cobb River to connect this shaft with shaft 2. Fisher (1946) provides a detailed account of the geological and geophysical excavations undertaken until October 1946.

Shaft Z was excavated as part of the earth dam drainage system, with four 3 inch diameter holes drilled at the top of the cross-drive to allow water to exit. This shaft was 8 ft by 8 ft and timber lined.

**Figure 6. Location of shafts and sinkholes.**

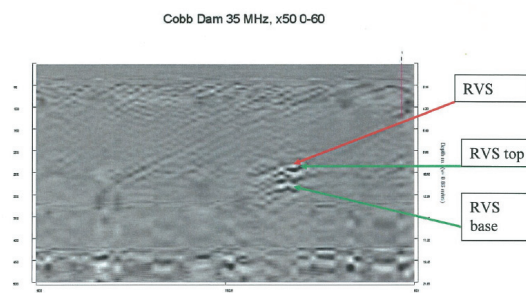
The geophysical survey identified the presence of possible large voids in or around shafts 1 and Z (Fig. 7).

These void targets have been interpreted as either indicating the presence of dry granular material in the shafts, or the presence of air voids. Ongoing discussions with Subsurface Imaging Ltd have confirmed that the most likely interpretation of the target signatures is that they are consistent with air voids.

**Figure 7. GPR data example of radar void signature approx 2-2.8m high**

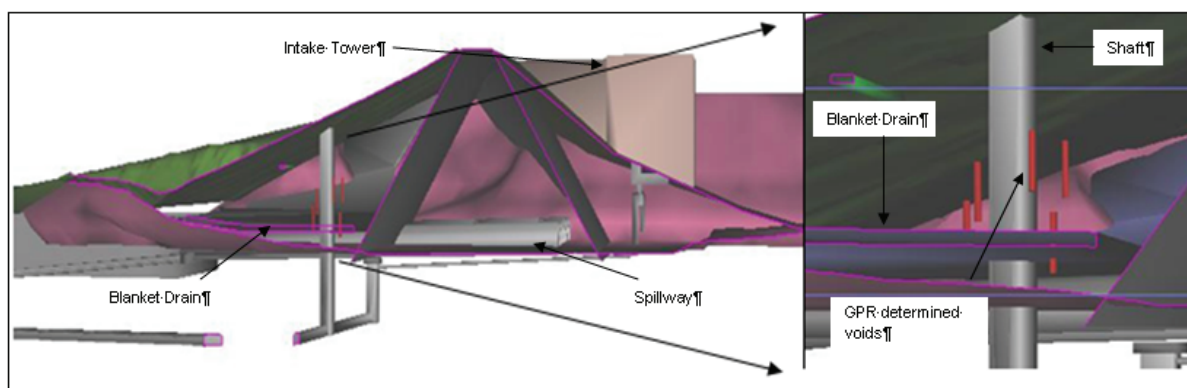
A 3-D model of the dam structures and zoning was developed to help interpret the relationship of these targets with in situ material (Fig. 8). The targets all cluster around the shafts generally above the level of the blanket drain.

**Figure 8. 3D model of dam cross section with close up view of GPR determined voids (red zones)**

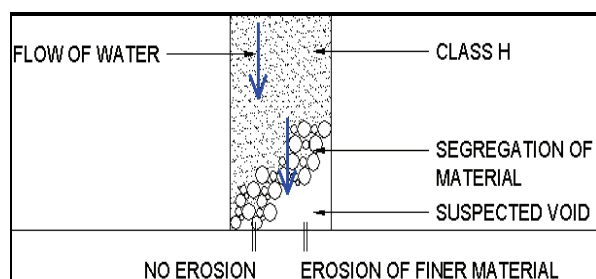
Characteristics of the Class H material in the shafts suggest that this material is segregated. The maximum particle size of 150 mm, the low percentage of sand and fine gravels (25% finer than 4.75 mm), and the probable end-dumping from trucks and high lift heights are all typical precursors of segregated soils. Segregation of material may also have contributed to the internal movement of fine material, which has undoubtedly occurred as evident from a post-construction note from the site office to the Hydro Design office in Wellington about the need for monitoring discharge (of stones and muddy water) from the drainage holes in shaft Z (Cowie 1957).

The water in shaft Z drains to the cross-drive through four 3 inch holes. An inspection of these holes was undertaken during the site inspections and found that the first hole was blocked and the second hole had water seeping out. A long crowbar was inserted into the third hole with no resistance, indicating a large void immediately above the cross-drive, and when it was inserted into the fourth hole a small amount of fine gravel came out.

The void in shaft Z above the cross-drive was probably caused by the movement or removal of Class H material by water exiting the drain holes. It is inferred that, due to the probable segregation of the material, the finer fraction has been washed out of the drainage holes into the cross-drive until it has re-sealed. Prodding the material as discussed above induces flow of water and sediment through the holes. Arching of segregated large gravel has likely created a void above the cross-drive (Fig. 9).

**Figure 9. Schematic of Shaft Z showing segregation of material and loss of fines.**

- CCTV inspection of drain holes in shaft Z to determine if the segregation and erosion cavities in the shaft base exist.
- Test pit sampling of the shaft backfill and crest materials to determine gradings and compatibility with surrounding materials.
- Installation of deformation survey markers to monitor settlement at the shafts.
- Commissioning of turbidity monitoring.
- Full geotechnical and geological data acquisition for the dam site.
- Dam zoning compatibility assessment and identification of key areas of risk.
- Dam stability assessment.

- Enhanced Monitoring.
- Injection grouting of voids and shaft material.
- Forced settlement of material.
- Remove and replace shaft material.
- Replace surface material and level to adjoining surroundings.

The present consensus is that increased surveillance is appropriate at this time, as the inferred risks associated with the various other options are considered to outweigh the benefits until the cause of the settlement and exact nature of potential voids is determined. A comprehensive risk assessment has been proposed for the dam to test this option.
