# Successful performance of detention dams in the February 2004 Manawatu floods

Don Tate<sup>1</sup>

**Keywords:** Detention dam, Porewa, Tutaenui, Matarawa, Manawatu floods

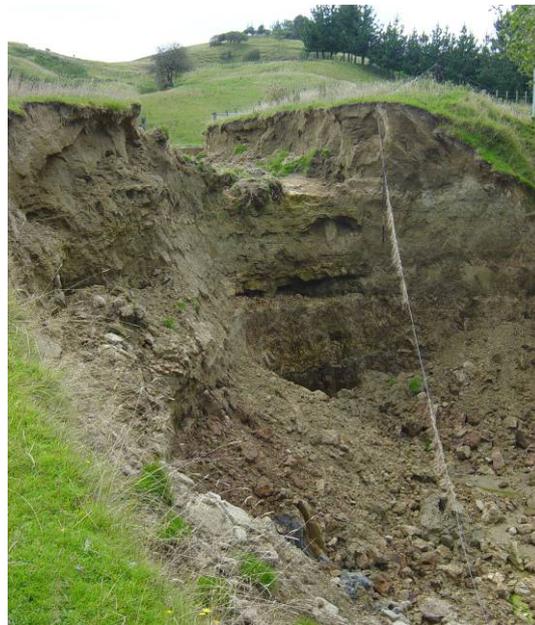
- Grass spillways performed in general very well, with only minor erosion. This appears to be due to very good grass cover and mild slopes.
- Significant damage to spillways was observed in two dams. One was related to headward erosion where the spillway terminated in a very steep slope down to the main stream. The second was due to spillway flow reactivating a pre-existing slip on which the spillway was located (see Figures 3, and 4). Significant repairs were required to the spillway in each case, but neither event endangered dam integrity.

**Figure 3. Slippage on spillway of Porewa No. 62**

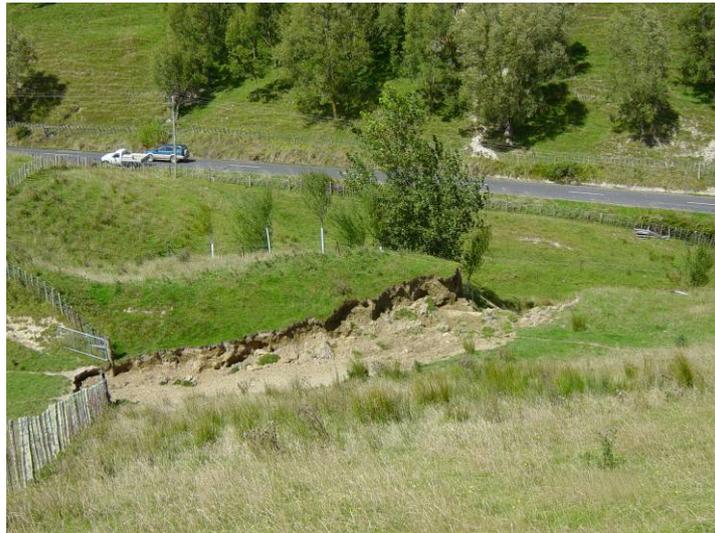
**Figure 4. Damage to spillway channel of Porewa No. 62**
