The long-term performance of seepage improvement works at New Zealand dams and canals

Don Tate

Director, Riley Consultants Ltd

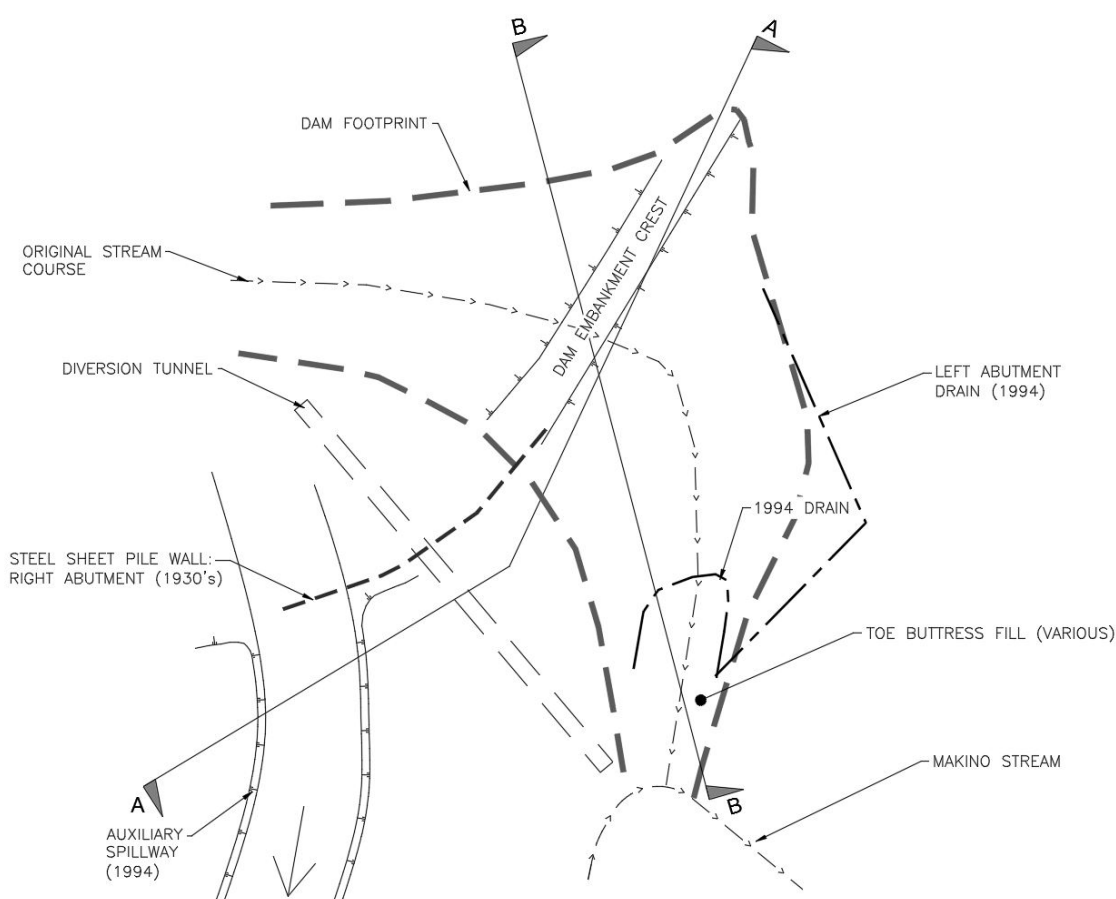
Figure 1: Ratapiko dam plan

Seepage issues observed at this dam are principally related to permeable sand layers at the abutments, which have saturated the toe of the dam (Refer Figure 1 and Figure 2). The original steel sheet pile wall on the right abutment appears to have performed well over a long period and a significant head loss is recorded in piezometric levels either side of the wall and with no uncontrolled seepages. The 1994 works showed satisfactory performance for a time i.e. reduction in piezometric levels and control of seepage in the critical toe area of the dam. However, there were concerns of a slow deterioration in performance over a period from 2000 to 2015. The key observations were that total drainflows decreased from an average of 174 litres per minute in the three years after 1994 to an average of 50 litres per minute by 2015 (Refer Figure 3). There were also corresponding increases in piezometric levels although individual trends were complex. The most marked increases were at or near the dam toe where increases of 0.8m to 1.5m were recorded. This was about 500mm below ground level (Refer Figure 4).

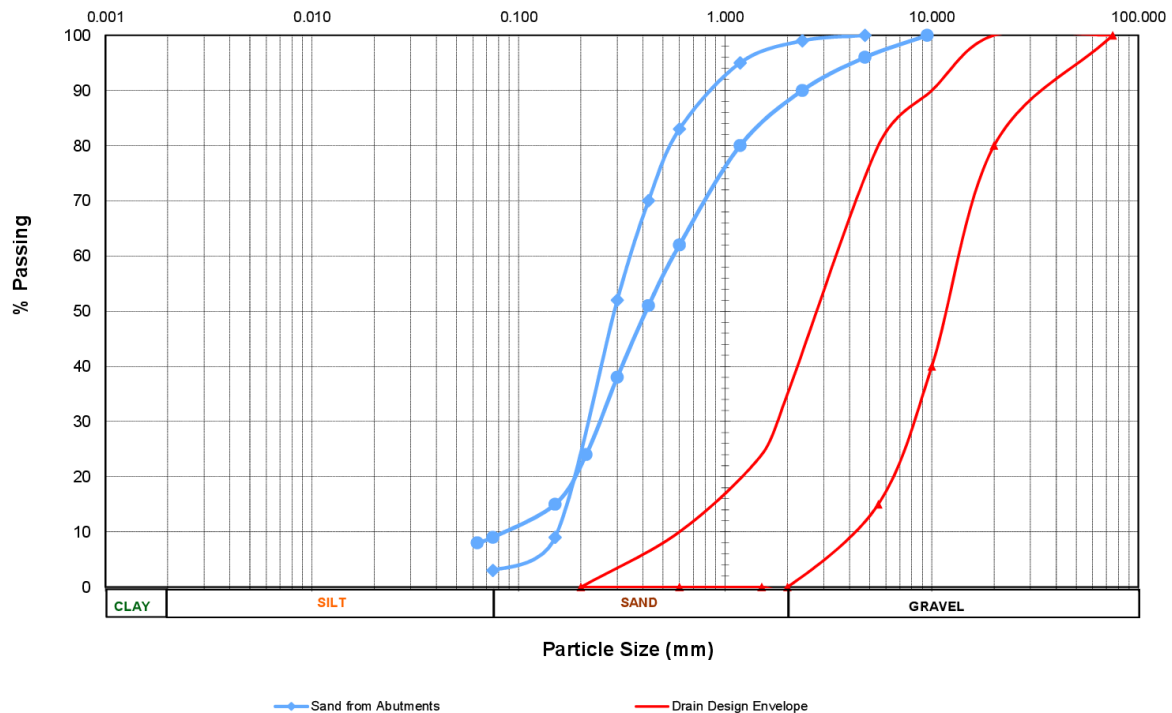
Figure 5: Grading curves of in-situ sand and drainage material

- The left abutment drain in the sand layer has a high capacity, well in excess of the recorded flows, and largely meets no erosion criteria with respect to the permeable sand (Refer Figure 5).

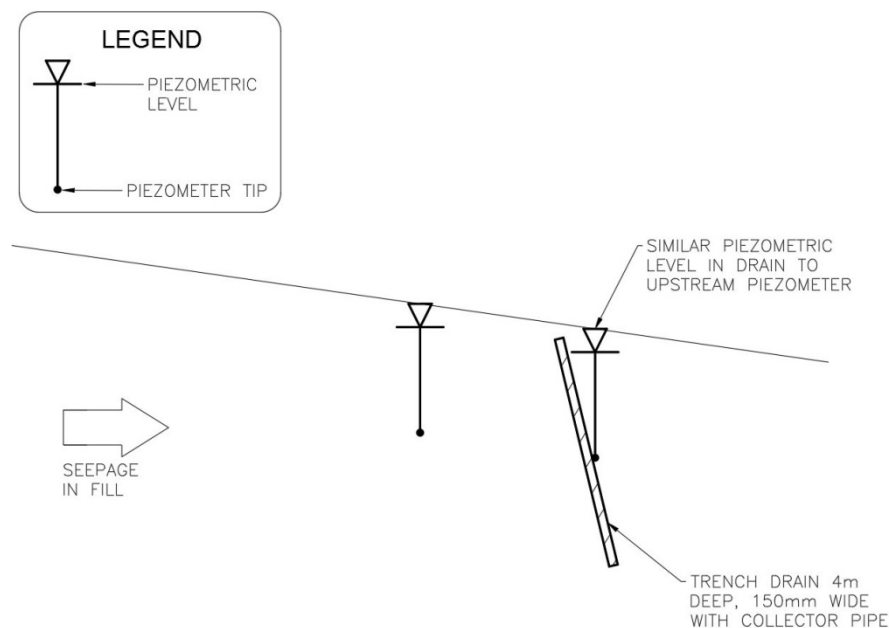
Figure 6: Piezometric levels and 1994 trench drain

- The deterioration in drain performance, as evidenced by increasing piezometric levels and decreasing drain flows, is largely related to the low capacity of the trench drain at the dam toe, although the drain meets the no erosion filter criteria. It is also postulated that some clogging of the drainage system may have contributed to the deterioration. Investigations showed that either side of the drain, there was a similar piezometric level whereas some head loss would be expected (Refer Figure 6). If the drain was fully effective, seepage flows would flow into the near-vertical trench drain and reduce the piezometric level on the downstream side of the drain.
- The sand materials are susceptible to liquefaction, which has serious implications for dam stability by several mechanisms.

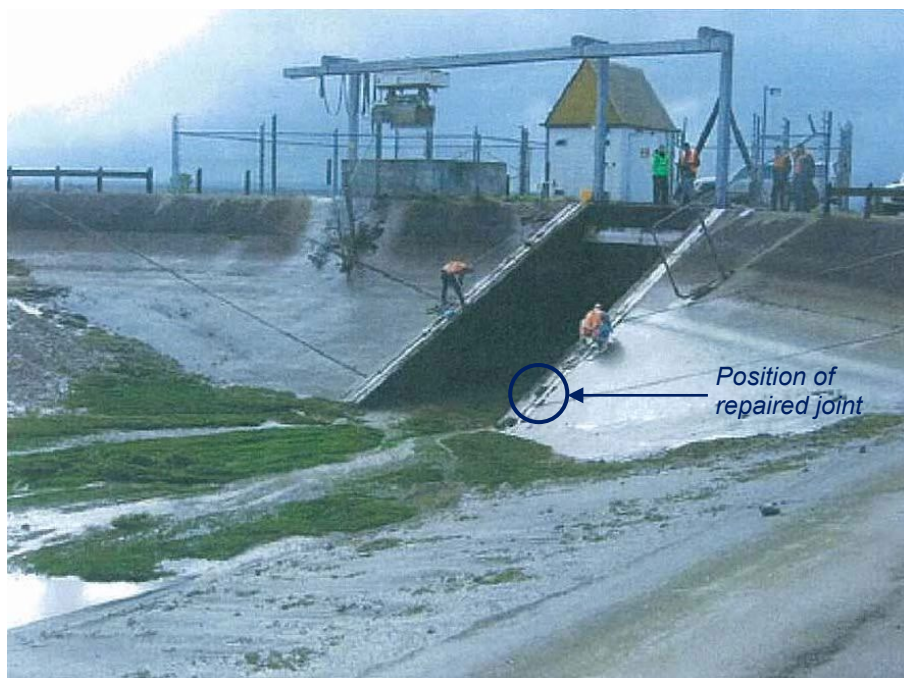
Illustration 1: Dewatered forebay area in 2009

The repaired areas operated without incident for about 25 years. After this time, however, both forebay areas suffered deterioration as evidenced by increased leakages that were detected by the monitoring system (Refer Figure 8). The following describes the repairs at the Flaxy forebay. Dewatering and shutdown of the canal was required to allow further repairs to be made in 2009, as shown in Illustration 1. The joints between concrete sections had deteriorated and allowed increased amounts of water through. There was no indication of any threat of an uncontrolled failure as the drain systems controlled the increased leakage, and there was no visual evidence of water breaking out in an uncontrolled manner, i.e. downslope of the forebay area as had occurred in the 1982 failure.

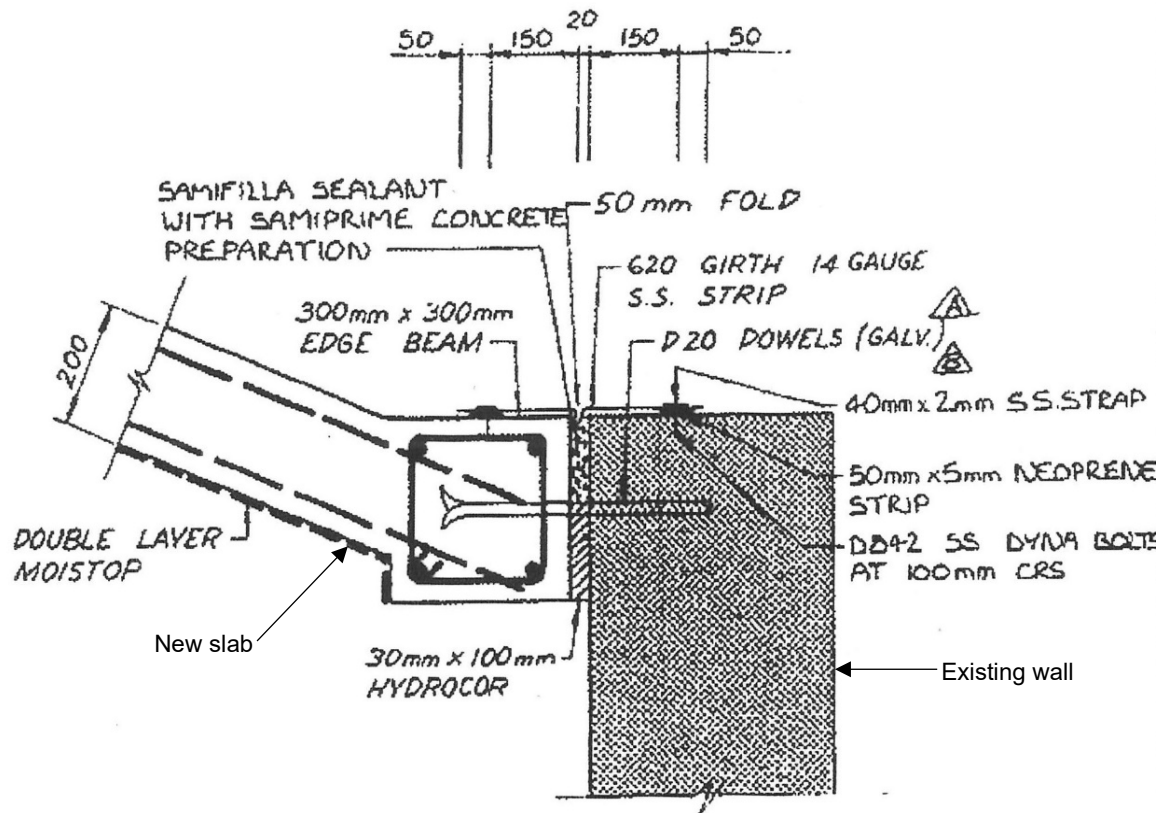
Figure 9: Flaxy forebay sealing detail – 1983

The Flaxy forebay remedial works was a particularly challenging design as the new concrete lining had to be attached to an existing concrete intake structure with vertical walls (Refer Figure 9). The detail used was a stainless-steel strap bolted to the existing and new concrete, which was the primary waterstop. The new concrete slab was locally thickened and attached to the existing wall with dowel bars. A gap (20mm) was designed between existing and new concrete with sealants within the gap. This was regarded as a secondary waterstop and would rely on adhesion to maintain a seal. When the canal was dewatered and inspections were carried out in 2009 it was clear that this sealing detail was ineffective. It was replaced by a proprietary product that could accommodate movement. The work involved replacement of the damaged sealant with a new sealant product and an exterior waterstop to replace the stainless-steel strap. The exterior waterstop comprised a Hypalon sheet embedded in an adhesive that was fitted to the concrete (Refer Figure 10). The work was undertaken by specialist contractors with continuous supervision by an experienced engineer. In the 10 years since the repairs were made, the performance has been satisfactory, and leakage has been reduced to background levels. The lessons learned here are that the designed remedial drainage system and monitoring had quickly picked up a deteriorating situation, and the conservative design had ensured no risk of an uncontrolled release of water. A lack of appropriate monitoring in the original design had been highlighted in the reports on the 1982 failure. In the original failure there was no formal monitoring regime, and it was postulated that there would have been observable signs of distress, such as uncontrolled seepages that would have been a precursor to the failure. In the remediation works for the scheme after the failure, monitoring of performance was an integral part of the dam safety management system that proved effective in practice.

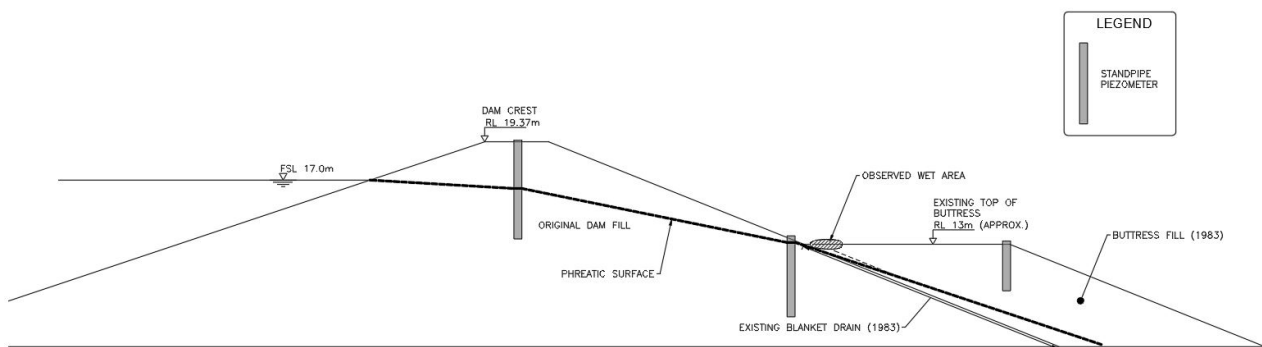
Figure 11: Dam A typical section

Increase in seepage in 1979 prompted investigations by a consultant. The outcome was the construction of a fill buttress to the downstream shoulder in 1983, incorporating a drainage blanket wrapped in geotextile (Refer Figure 11). The drainage blanket and buttress only extended to partway up the dam height, presumably to where seepage was observable on the dam face. The emergence of seepage at this location was related to the high horizontal permeability of the dam fill and likely some influence from seepage at the left abutment. Intermittent seepage monitoring continued up to 1995 when an inaugural dam safety evaluation was completed. At that time, a number of investigations comprising a series of deep machine boreholes, cone penetrometer tests, and installation of standpipe piezometers were undertaken as seepage was still apparent in some areas and there were still some uncertainties on seepage performance. In 1998 further works were undertaken: an array of horizontal bored drains into the base of the toe buttress and a trench drain adjacent to the left abutment where wet areas had persisted (Refer Figure 12). The bored drains were installed to draw down the phreatic surface at this location.

In 2017 an intermediate dam safety review identified that a new wet area was apparent on the buttress surface (Refer Figure 11), and further investigations were recommended on possible causes and remedial options. The author was involved in recent 2018/2019 investigations and implementation of additional shallow drainage trenches. Some surprises arose from this investigation; it appeared that the geotextile may not have extended as high as drawings indicated and the wet areas may be due to local filter incompatibility between the dam fill and the coarse drain material. Further down, the seepage appeared to be adequately controlled as the buttress was mainly dry, and 1983 photographs show the geotextile was present in the mid to lower sections of the buttress. The installation of further piezometers is pending as the seepage regime at present is not fully understood, although recent investigations have provided very useful information. The 1983 and 1998 remedial works have improved seepage control and overall stability but have not conclusively mitigated the seepage issues.
