Piping Failure of the Poihipi Reservoir

D. R. Tate

Director, Riley Consultants Ltd, Auckland

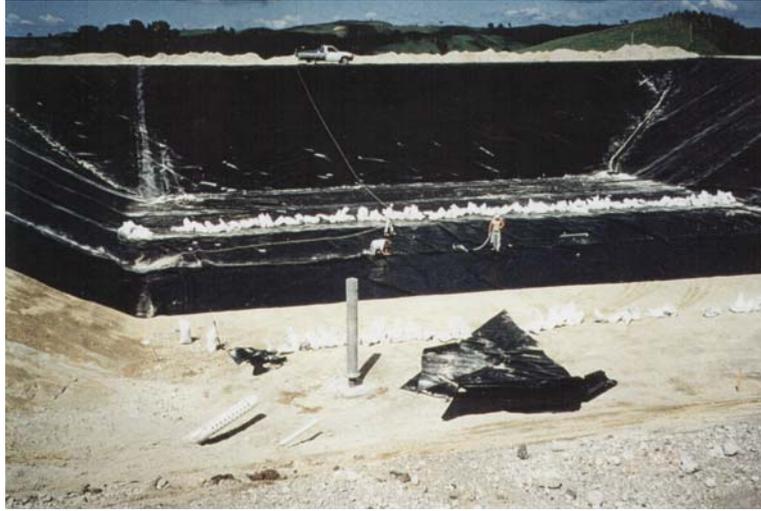
Figure 1. Original Reservoir during Construction.

The original reservoir was located on the top of a hill about 300m west of the power station. It was constructed from local pumiceous gravel, sand and silts. The majority of the reservoir was constructed in natural material with fill used to increase the height of the embankment to the required level on the south side. The reservoir was about 6m deep and was lined with HDPE to prevent water leakage. All seams were site welded. Three pipes penetrated the liner for inlets and outlets (Figure 1).

The most likely point of the initial leak is around the inlet/outlet pipes. At this position several adverse conditions existed:

- The pipes penetrated the liner at several points. The pipes penetrated the liner at a low level, and thus the area around them was subject to maximum hydraulic loads of about 6m of water.
- The trenches carrying the pipes were potential areas of differential settlement, because of the likely difference in compressibility of the trench backfill and the surrounding ground. The differential settlement would put the liner under considerable tension.
- The pipe locations coincided with the fault zone and contact between surficial tephra and loess and the more compact Oruanui Ignimbrite which could also lead to differential settlement.

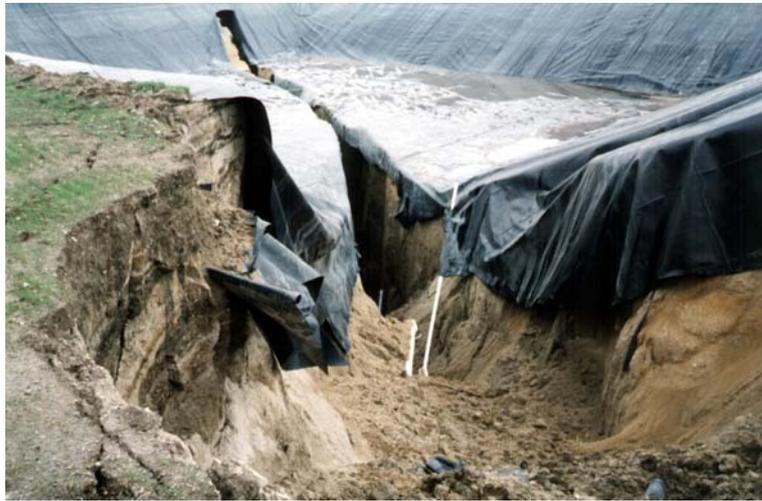
Figure 2. View along Failed Reservoir from Eastern Corner.

The visual evidence of the failure was remarkable. At the reservoir site, a very deep trench occurred diagonally through the centre of the reservoir, and the HDPE liner had been torn completely along the line of the trench (Figure 2). The trench was estimated to be at least 10m deep and up to a few metres in width.

- When the erosion pipe reached the reservoir, material was lost directly beneath the HDPE liner, removing support.
- The liner tore where the support was lost. Leakage then increased rapidly. Multiple flow paths with subsequent erosion were created, leading to total draining of the reservoir.

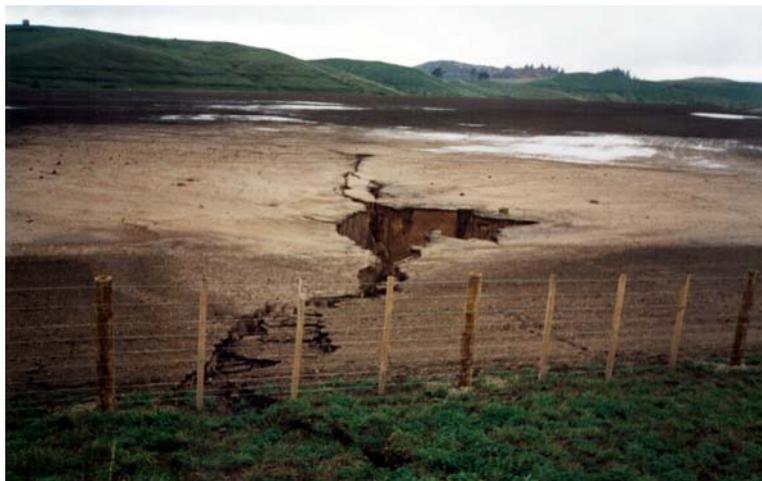
The reservoir water discharged at two main “break-out” locations well away from the reservoir. Beyond the eastern corner a long line of slumping and cracking was visible on the ground surface extending to drill pad 64. This pad was a large flat area created by cut and fill. A series of “erosion pipes” were observed in excavations clearly showing the erosion path (Figures 3, 4).

Figure 3. Breakout Point on Drill Pad 64.

- The seepage water broke out at the ground surface when the overburden stress decreased ie at the toe of the slope at the drill pad and/or the valley base. The heaved ground is evidence of high water pressure at depth.

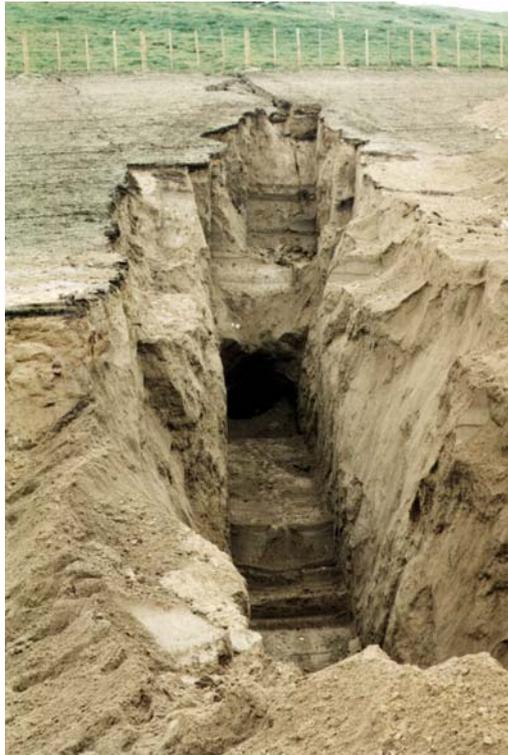
Figure 4. Erosion Tunnel at Drill Pad 64. The Tunnel was Encountered on the Reservoir Side of the Break Out Point.

- Internal erosion occurred backwards from the “breakout” point(s) forming a “pipe”, progressively back to the reservoir.

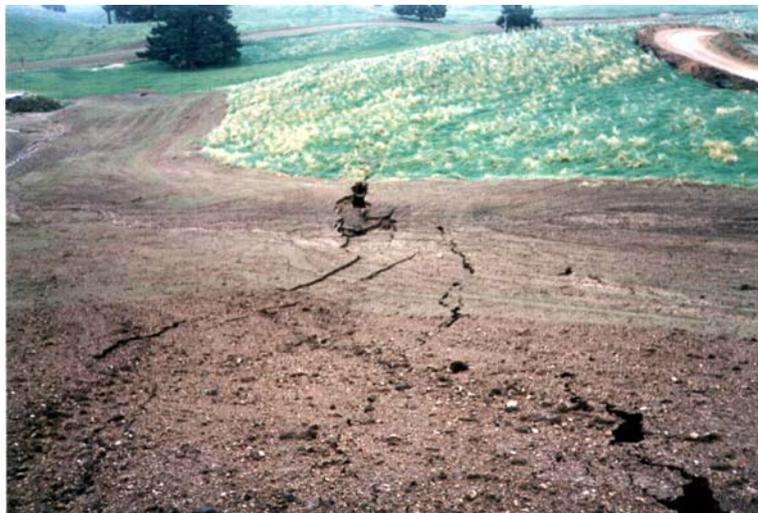
The reservoir water also discharged to the west of the reservoir. A line of slumping was visible down to the base of a ridge about 250m away. No cracking or slumping was visible until the breakout point at the base of a valley about 500m from and 55m below the reservoir (Figures 5, 6).

Figure 5. Subsidence Extending Southwest from the Western Corner of the Reservoir. The Gully in which the Water Exited (Figure 6) is Beyond the Far Ridge with Trees.

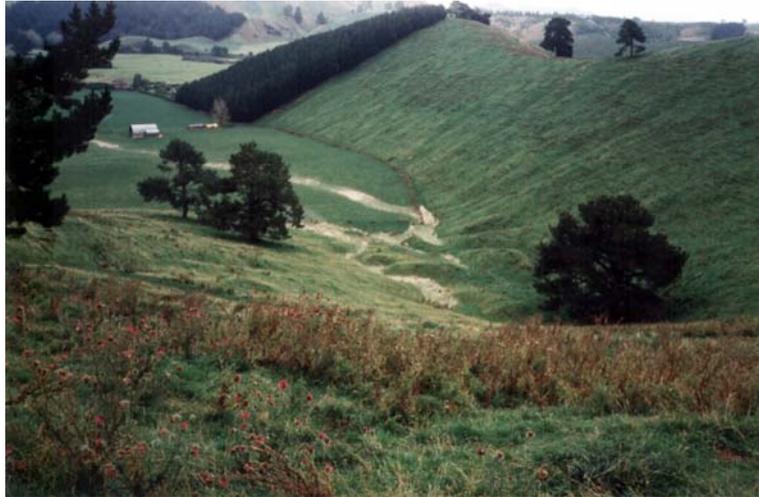
Figure 6. View Towards South Showing the Main Southern Water Outlet Area and the Flow Path Across the Valley Floor Marked by Sediment.

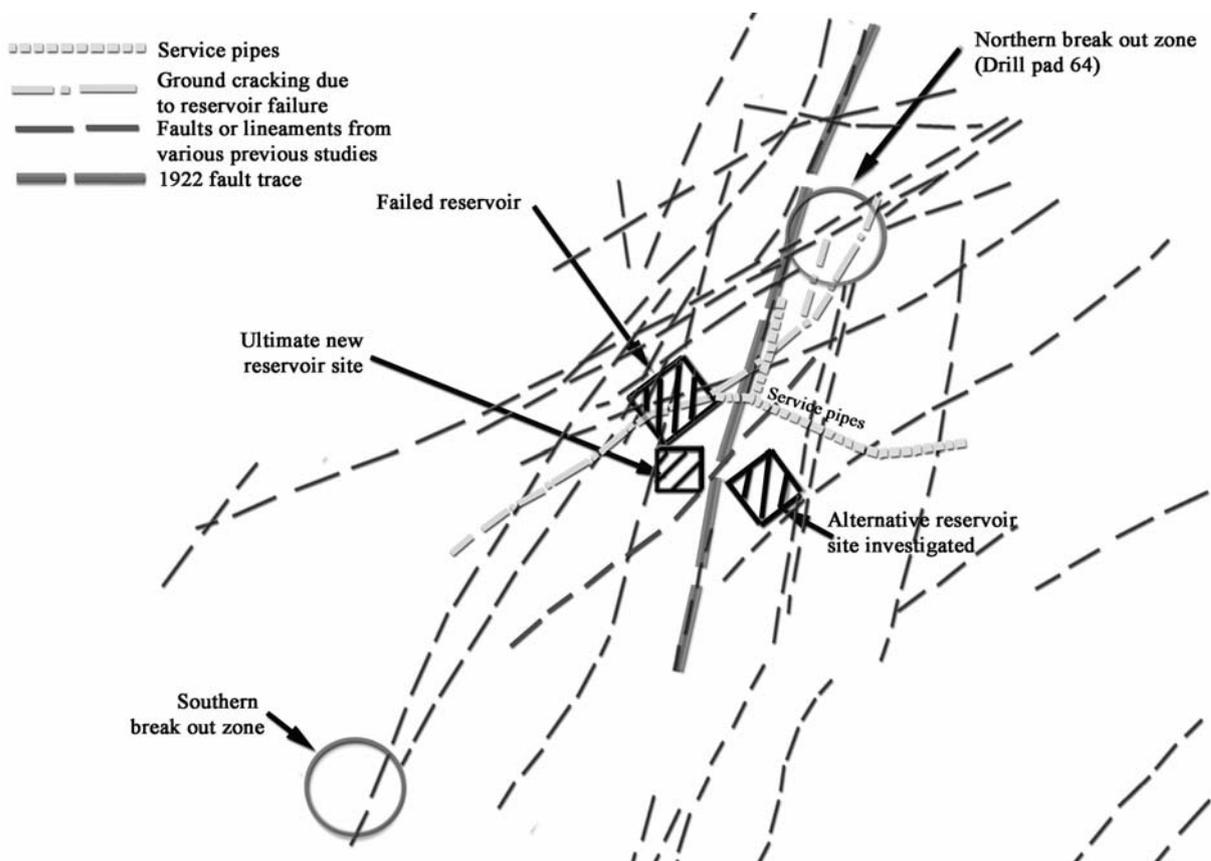
Figure 7. Previously Indicated Faults and Lineaments

Figure 7 shows the location of the breakout zones and prominent ground cracking relative to the reservoir. A cross-section is shown on Figure 8.

Previous studies for the site specifically addressed geological and seismic hazards. These studies identified possible faults on various orientations in the vicinity of the reservoir. Sections of the ground cracking/slumping coincide with previously identified faults, but none coincided precisely with the failure over its entire length. Figure 7 shows the proximity of the ground features to previously identified or suspected faults.

The intensity of faulting indicated that it was impractical to avoid the likely presence of active faults; given constraints on reservoir siting. The final site chosen is shown on the site plan, Figure 7.

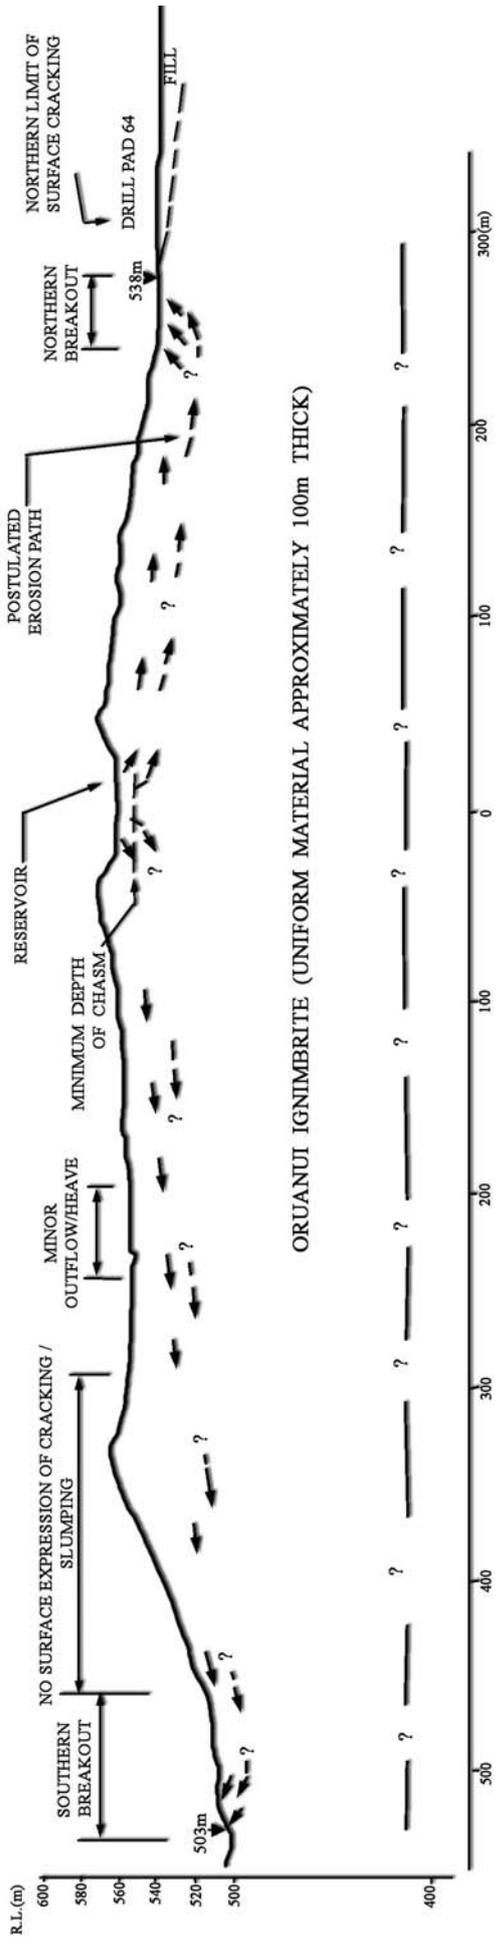
Figure 8. Cross Section along Failure Path

The fundamental cause of the reservoir failure was an uncontrolled concentrated leak from the reservoir, which led to internal erosion between a “breakout” point or points and the reservoir. The internal erosion occurred along the weakest line of resistance. The narrow linear nature of the erosion paths over extremely long distances indicate the erosion occurred along faults. The most likely sequence of events leading to the failure is summarised below:

- An initial leak occurred through the liner, most probably in the area where the pipes penetrated the liner.
- Seepage occurred at depth, along paths of low resistance provided by the fault. High pressures occurred because of the confined nature of the seepage path along a thin zone, and the rapid fall in ground contour away from the reservoir.

- Parallel cracking occurred on the ground surface coincident with the leakage paths. This cracking occurred by hydraulic fracturing, which is a phenomenon whereby water pressure exceeds the horizontal stress in the ground and cracks enlarge and propagate to the ground surface. Faults and the junction of the access trench (for the pipes) with natural ground are points of low horizontal stress. The tendency for cracking at the ground surface decreased as the overburden stress increased ie when the seepage path went beneath a hill
