Rosedale Dam – Issues associated with a high-hazard dam in an urban area

S Singleton,¹ D Tate² and P Riley³

The Rosedale Dam retains the No 1 oxidation pond at the Rosedale Wastewater Treatment Plant facility. The pond has a surface area of 36 hectares and an impounded volume of over 1 million cubic metres. The dam owner, the North Shore City Council, is presently applying to the Auckland Regional Council and the North Shore City Council for renewal of resource consents for the Rosedale Wastewater Treatment Plant facilities. The treatment plant handles all the sewage from the North Shore area, which has undergone rapid growth since the plant was commissioned in the early 1960s. Stormwater flows from surrounding catchments are diverted around the reservoir by a ring drain.

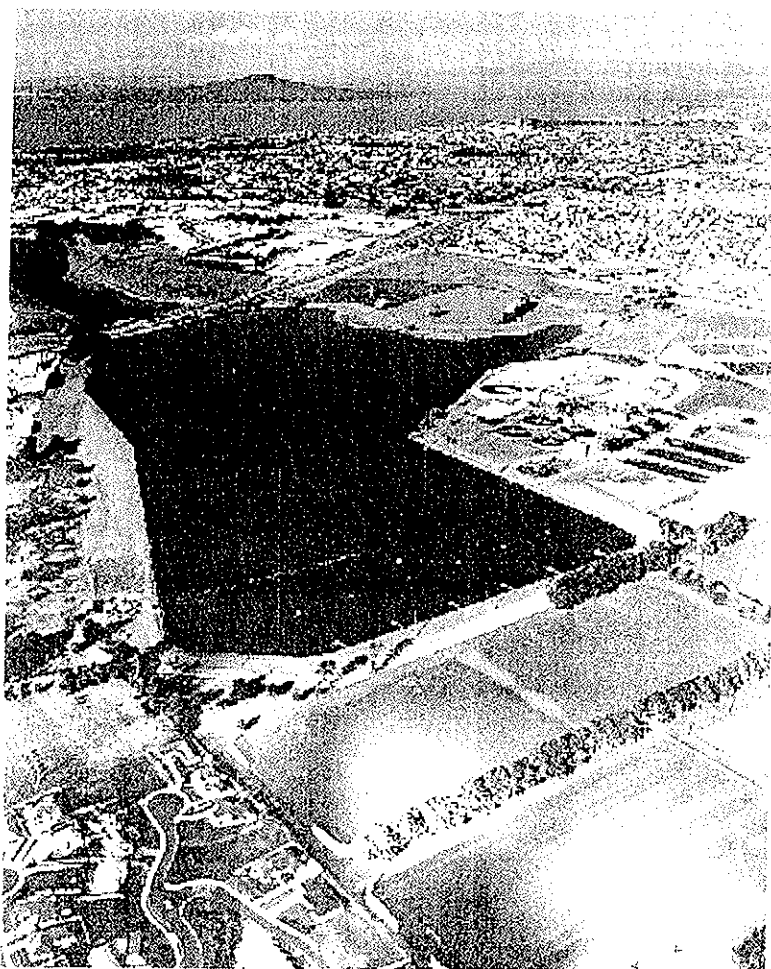
Figure 1. Rosedale Dam and North Shore City, with Rangitoto in the background.

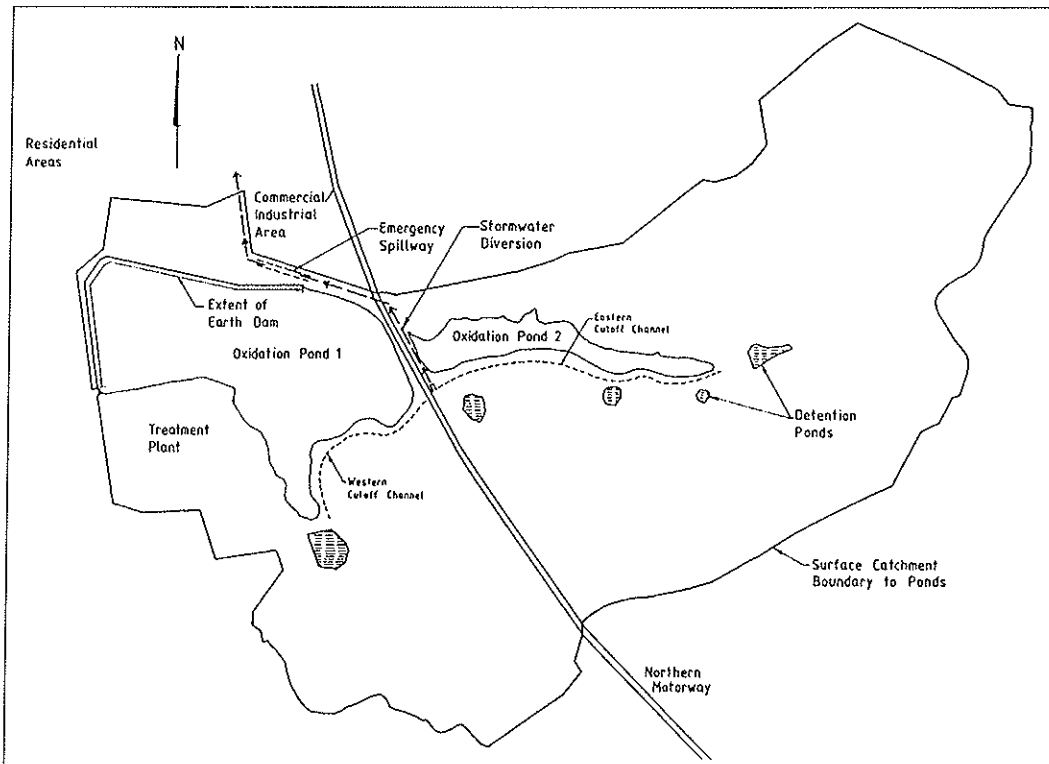
Figure 3. Extent of the dam, and its main features.

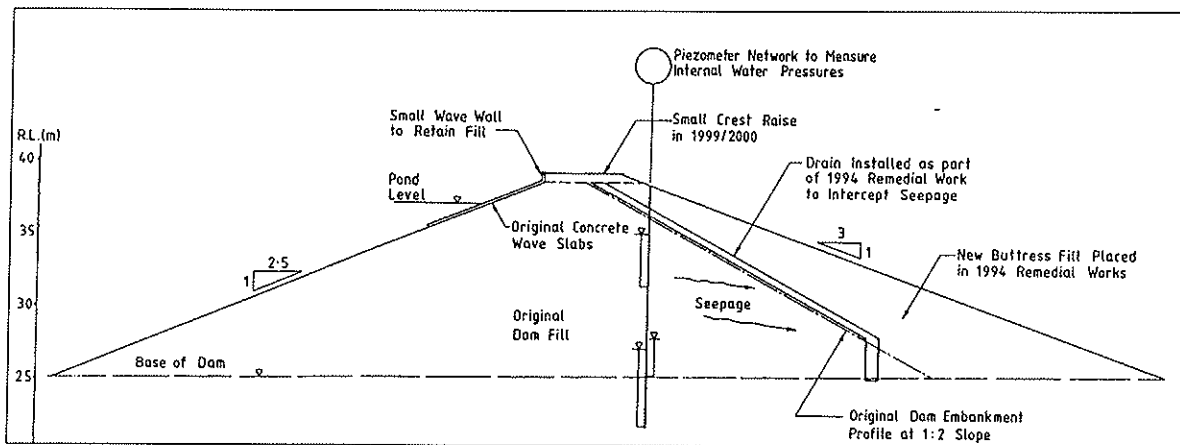
Figure 4. Typical cross-section of the Rosedale Dam.

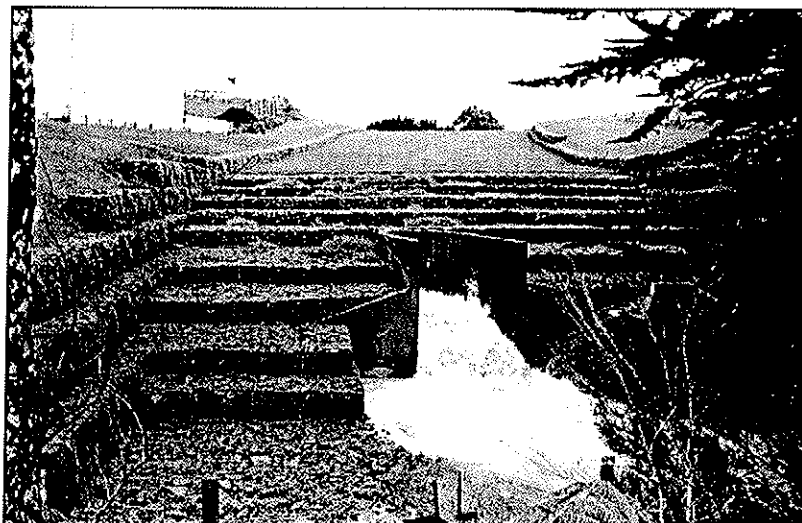
Figure 5. Emergency spillway, stormwater diversion operating.

- The dam crest was raised by about 600 mm for greater flood freeboard and wave run-up resistance, and to discharge the PMF without overtopping the dam.
- The grassed emergency spillway was improved by regrading, gabion protection, grass reinforcement utilising Tensarmat, and improved geometry. The PMF design flow was 25 cumecs, or 0.8 m³/sec/m of crest length.
- A small concrete wave wall retained the additional fill on the dam crest.
