Design and construction of a commercial building on a closed municipal solid waste landfill in Takapuna, Auckland

ABSTRACT

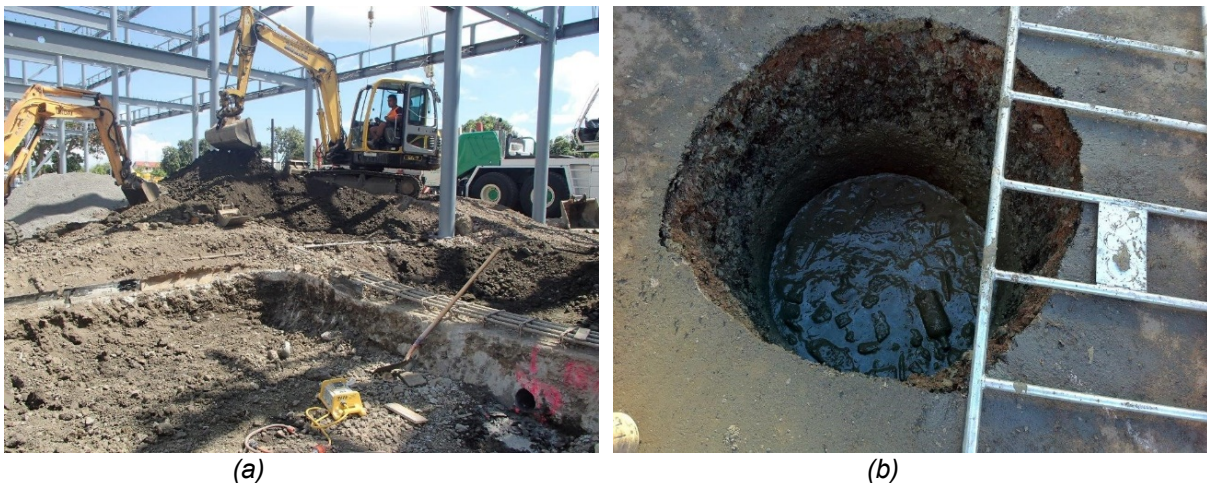
Floor levels were positioned to minimise excavation into the refuse. However, due to the highly variable thickness of the landfill cap (which is not consistently in place across the site), it was difficult to predict the volume of excavation into the refuse during ground works. Large amounts of refuse, consisting of bottles, glass, metal pieces, plastic, etc., along with a strong odour were encountered during site excavations – refer Figure 4(a) and (b).

Figure 4. (a) Excavation within landfill; and (b) Landfill refuse observed

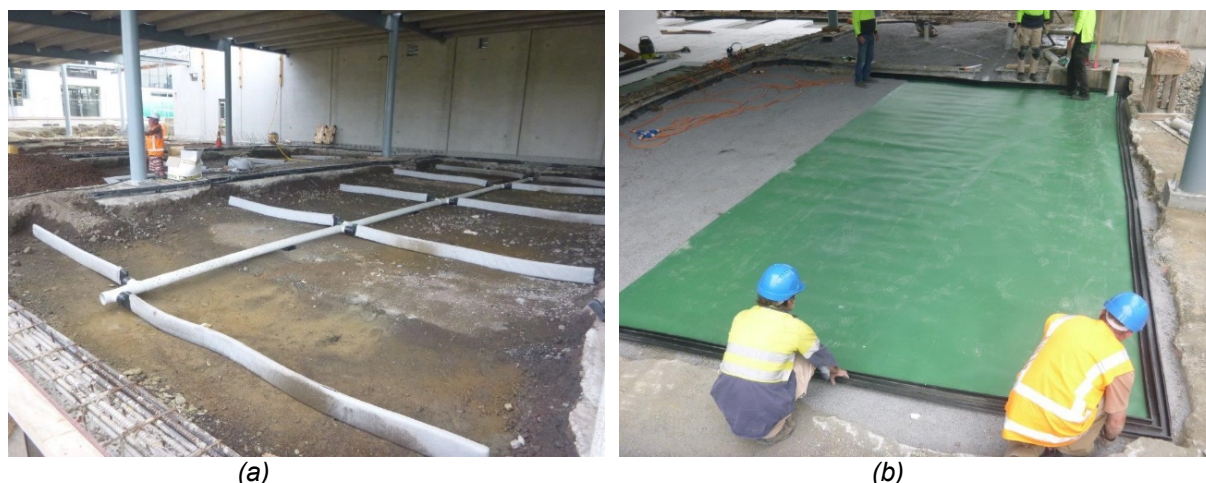
Figure 5. (a) Gas collection network; and (b) Placement of HDPE membrane

The subgrade for the gas manifold system was prepared by removing all sharp objects on the surface and proof-rolling. On completion of the subgrade preparation the manifold pipes were assembled within individual foundation compartments (divided by ground beams). To accommodate the slight difference in size and shape of each compartment, the length and space of the drains and pipes were adjusted on-site, under the instruction of the Engineer. Figure 5(a) shows a typical alignment of an assembled manifold system, prior to placement of the granular venting layer. The top blinding layer was hand placed to ensure a smooth finishing surface for the HDPE membrane.

The HDPE membrane was installed by a specialist contractor under full time observation of the Engineer to ensure the manufacturers' requirements for the gas membrane were correctly adopted and the membrane was undamaged. Extrusion welding, a technique that 'glues' HDPE materials together by using hot polyethylene, was utilised to weld the HDPE membrane to the T-locks. Quality control, via spark testing (electrical current passed through copper wire to generate spark), was undertaken on completion of membrane placement within each compartment, to detect if there were any unsealed/damaged spots.

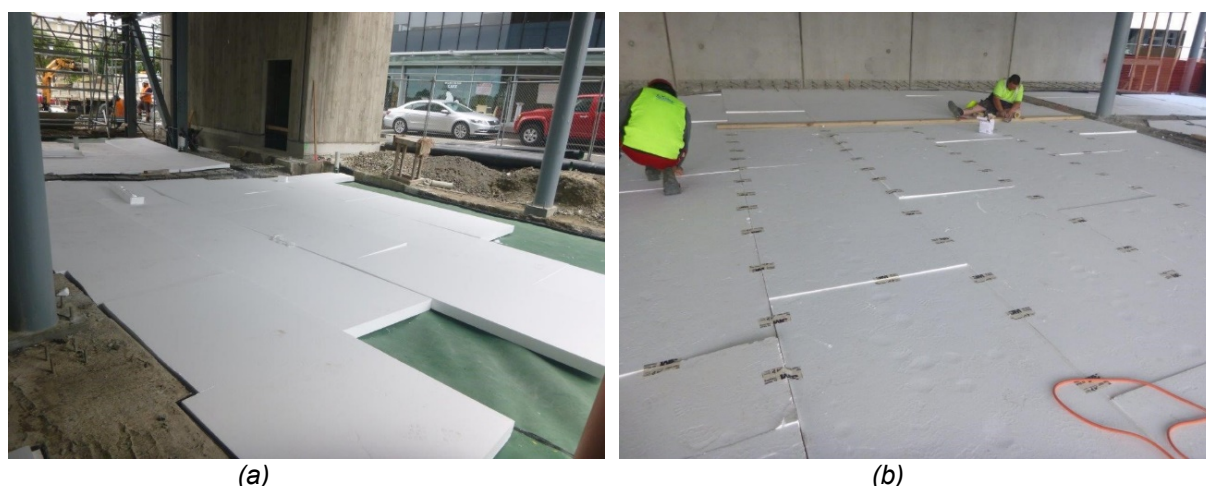
It was noted by the Engineer that the membrane (which had been installed and tested) was regularly damaged by site personnel. Frequent repair (in conjunction with re-testing) of the membrane was time consuming and could reduce the performance of the gas membrane. Following numerous discussions with the site contractor, placement of blocks of expanded polystyrene (EPS) lightweight fill on top of the membrane was considered the most practical solution to prevent further damage – refer Figure 6(a). The lightweight fill blocks were closely butted and taped to further minimise physical contact with the HDPE membrane, as shown in Figure 6(b). Subsequently the HDPE membrane remained undamaged.

Figure 6. (a) EPS fill on HDPE membrane; and (b) Closely taped EPS fill
