An Unusual Contact – Whitford Quarry, Whitford

Riley Consultants Ltd has been involved in stability assessment of existing and proposed cuts and excavations within the quarry. During our inspections of the cut faces the geological contact between the older 'greywacke' and considerably younger overlying sediments has been exposed at several locations.

This article presents a brief summary of the nature of the contact including cursory observations and stability characteristics of the geological units in proximity to the contact.

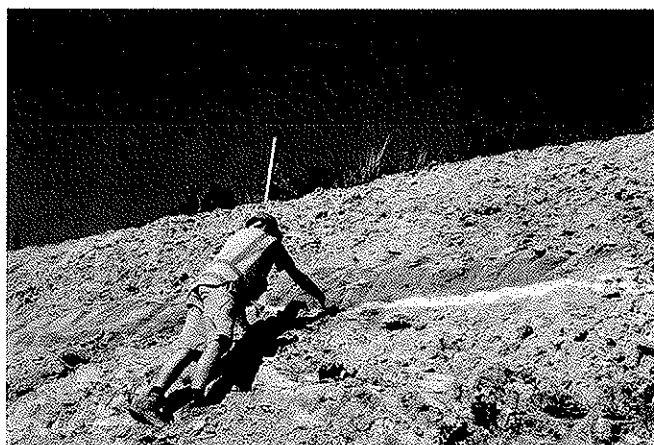
Figure 2: Exposure near crest of highwall in 2005. Geologist is picking at white chalky material whilst standing on highly weathered greywacke rock. Above is pebbly Cape Rodney Formation.

At approximately RL120, near the highwall crest, highly to completely weathered greywacke rock is overlain by CRF. The contact is gently undulating, though would appear to have an overall gentle dip to the north (6° to 8° northward based on structural contouring).

Interestingly, during excavations in 2005 an unusual exposure was created of approximately 1m-3m of CRF overlying a unit of weathered sand. This lensoidal sand ranged in thickness from 0.0m to 0.6m and appeared to be infilling a palaeo erosion surface on the weathered greywacke below, but also possibly inter-fingering with the CRF at the extremities (although this is uncertain due to limited access). Within the sand were lenses of a white chalk like material up to 0.15m thick. The 'chalk' contained pockets of carbonaceous material up to 5cm thick and 30cm in length. These pockets contained unusual rounded pebbles, inferred to be weathered sandstone. This material extended some 20m laterally and is shown in figure 2.

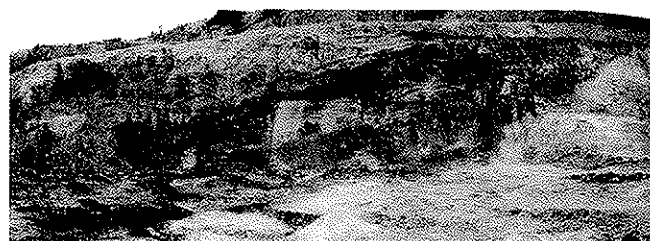
Figure 3: Exposure at northern extent of quarry showing dipping weathered greywacke, the top of which is marked by dark greenish colouration. This is overlain by mixed deposits including dark brown silt, which is apparently unconformably overlain by Cape Rodney Formation. The Waikopua Fault is some 90m to the west (left).

Recent excavations at the northern extent of the quarry have exposed the contact between the greywacke and overlying units as shown in figure 3. This can be compared against the limited exposure in the current highwall as discussed above. The greywacke has an undulating palaeo-surface with apparent channel infill and beds of dark brown (possibly carbonaceous) silt, similar to that observed in Waikato Coal Measures (Te Kuiti Group) seen in Papakura. Also included are apparent rounded greywacke gravels (often with a yellowish sulphur colouration). This sequence is no more than 1m thick over the exposed section with carbonaceous beds dipping sub-parallel with the greywacke interface. It appears to have an undulating, unconformable

contact with the overlying CRF pebbly beds above, with an average interface dip of 22° to the northwest. Within the CRF were organic silt horizons with a bed dip of approximately 6° northwest.

The upper, completely weathered greywacke had a greenish colouration, which is unusual compared to other current Whitford Quarry exposures.
