Design, construction and commissioning of the Deep Stream hydro-electric scheme

D. R. Tate, V. M. Martin, Riley Consultants Ltd
J. Pearson, TrustPower Generation Ltd

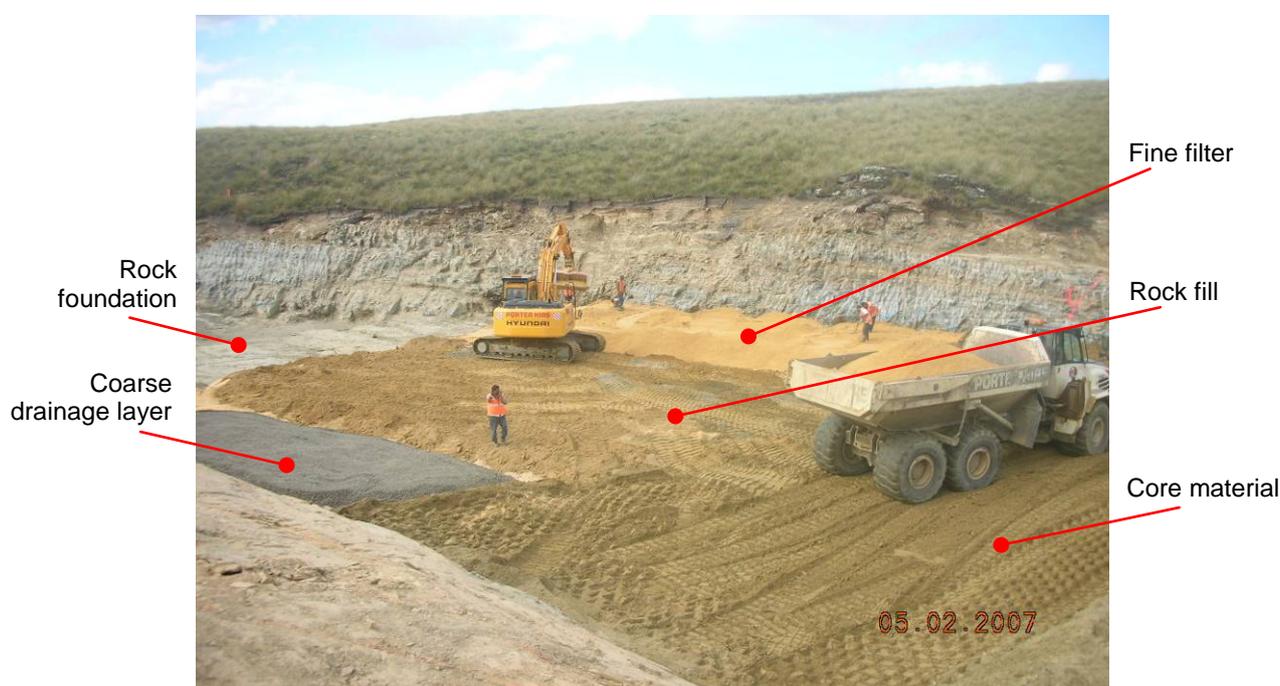
Photo 1: Main dam showing the dam core and the various drainage layers

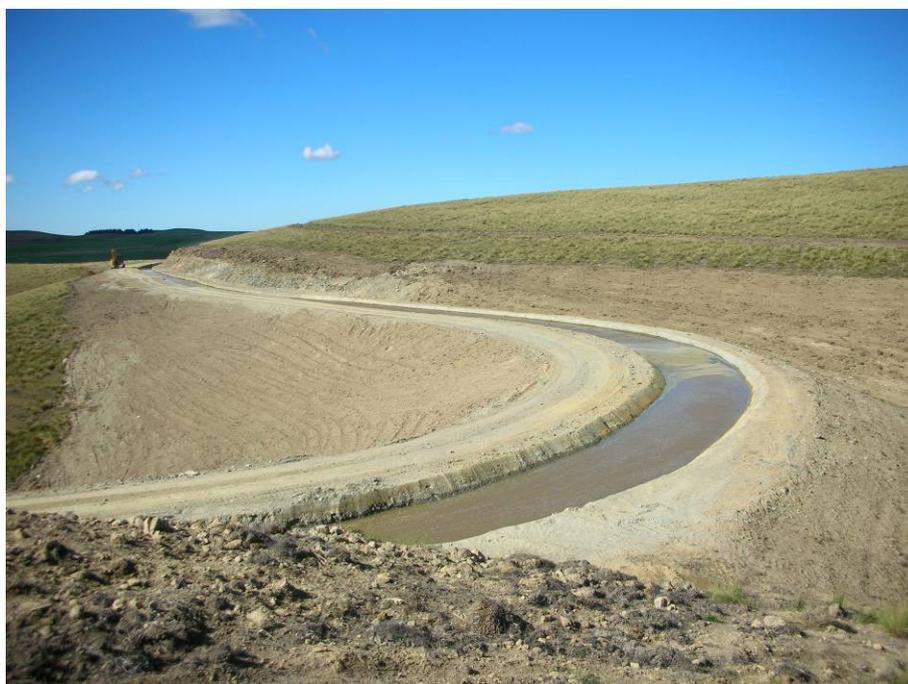
Photo 2: Canal at largest fill embankment.

- Fill embankments generally had relatively steep batter slopes of 1:1.5 V.H., as it was considered schist rock had a reliably high strength, and most fills were less than about 10m height. The largest fill of 20m height was flatter at 1:2. Toe drains were specified at the toe of the larger fills.

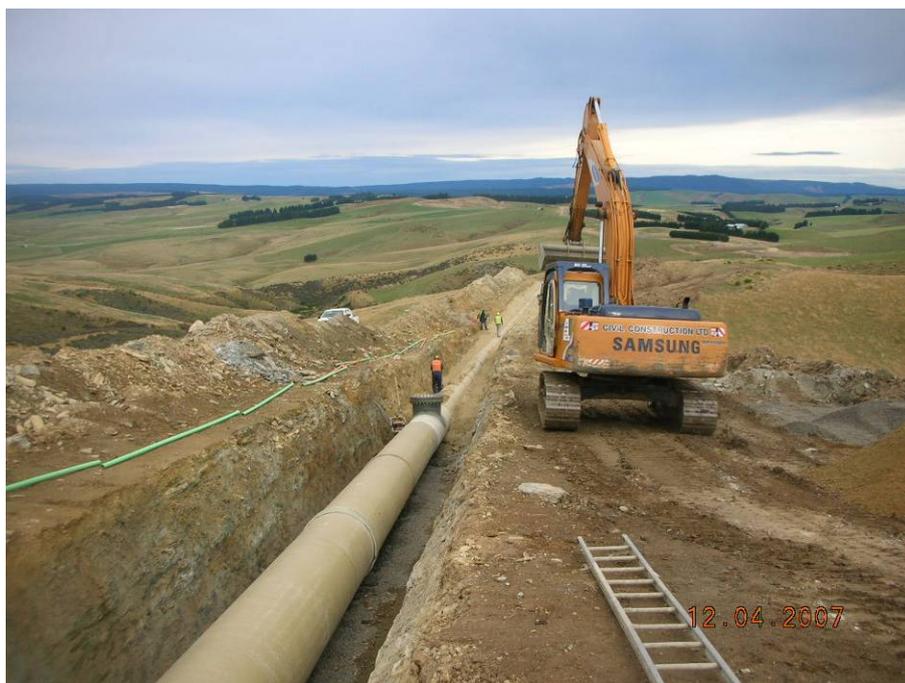
Photo 3: Penstock construction.

Initially conventional (in-ground) steel penstocks were designed. GRP penstocks were promoted as a possible cost-effective alternative in the latter design stages, and were ultimately adopted by TrustPower. The penstock design was altered to accommodate the nesting of pipes for transport which resulted in a significant shipping cost saving.

The pipe sections were comprised of 1,100mm and 1,000mm diameters with pressure ratings of PN6, PN10 and PN16. Station 1 had a gross head of 135m with 1,100m of buried penstock and Station 2 had 148m of gross head with 1,900m of buried penstock. Each penstock line incorporated inspection hatches to surface at approximately 200m intervals. During construction, the jointing of the penstock sections was done either via an outer coupling joint on straight sections, or on site fibreglass jointing. QA testing was performed on all joints during installation. It is noted that the installation and backfill criteria was more stringent as compared with steel, and anchor block designs were much larger than with steel, but a net saving was still achieved with the use of GRP.

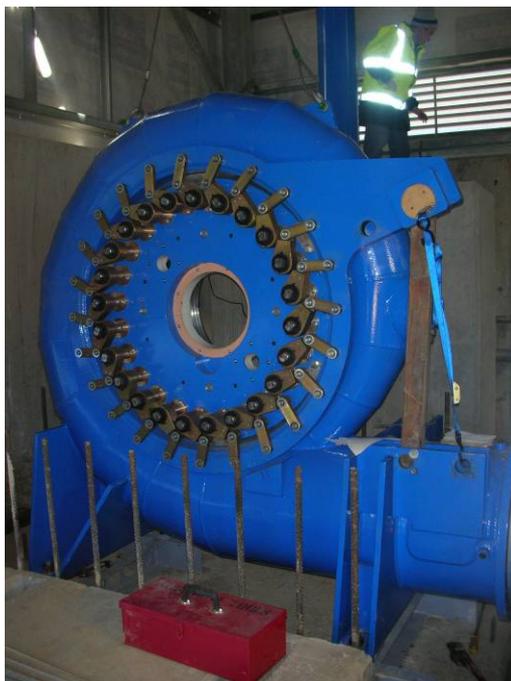
Photo 4: Powerhouse 1 turbine.

The turbines for the project were designed and fabricated in Christchurch. With this, close involvement by TrustPower in the design and fabrication process ensured a high quality, fit for purpose result. Each station's turbine was an identical design based on a mid-point between the 135m and 148m gross heads for Station 1 and Station 2 respectively. The design flow was 2.5 cumecs based on the resource consent discharge requirements from Station B into Northwest creek. The turbines were of a Francis type with an "X" blade runner design. The turbines did not employ the use of a governor (not required by the System Operator) and are actuated. A full flow bypass was also designed and installed, allowing for each station to continue to function if the other Station was inoperable due to maintenance, etc. The turbine designer also designed all of the station services and hydraulic systems. The installation and alignment of the turbine / generator package was carried out by TrustPower's regional staff and commissioning was a combined effort by Hydroworks and TrustPower staff.
