Upgrade of Mangamahoe Dam Spillway

D.Tate G.Euinton (Riley Consultants) W.Robbins (TrustPower Ltd.)

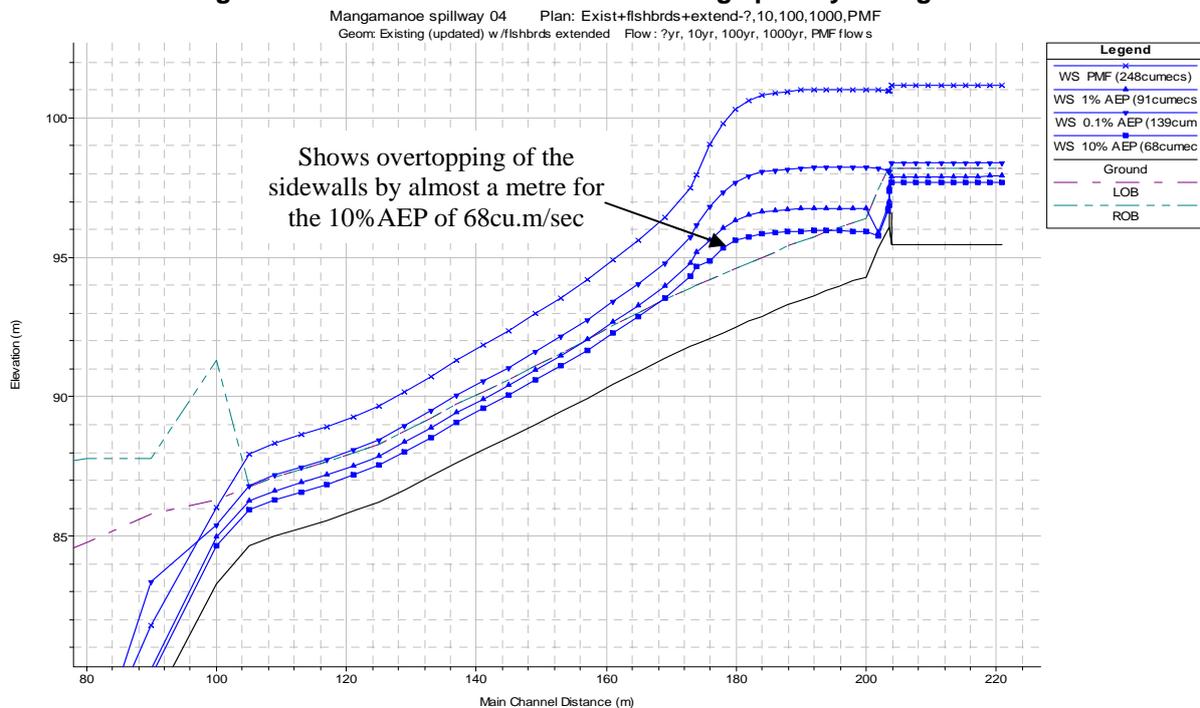
Figure.1 Peak water levels for the existing spillway configuration

The ogee crest spillway on the right abutment has a crest length of 30.5 metres and a total freeboard of 2.33 metres to the current crest level. These dimensions give the spillway crest a capacity of 195 cubic metres per second. The chute is concrete lined with 2.1metre high side walls downstream of the headwall. The chute width reduces from 30.5 metres to 3.66 metres within 30 metres of the crest. The diagram below shows the water surface profiles for various floods flowing along the original spillway return channel.

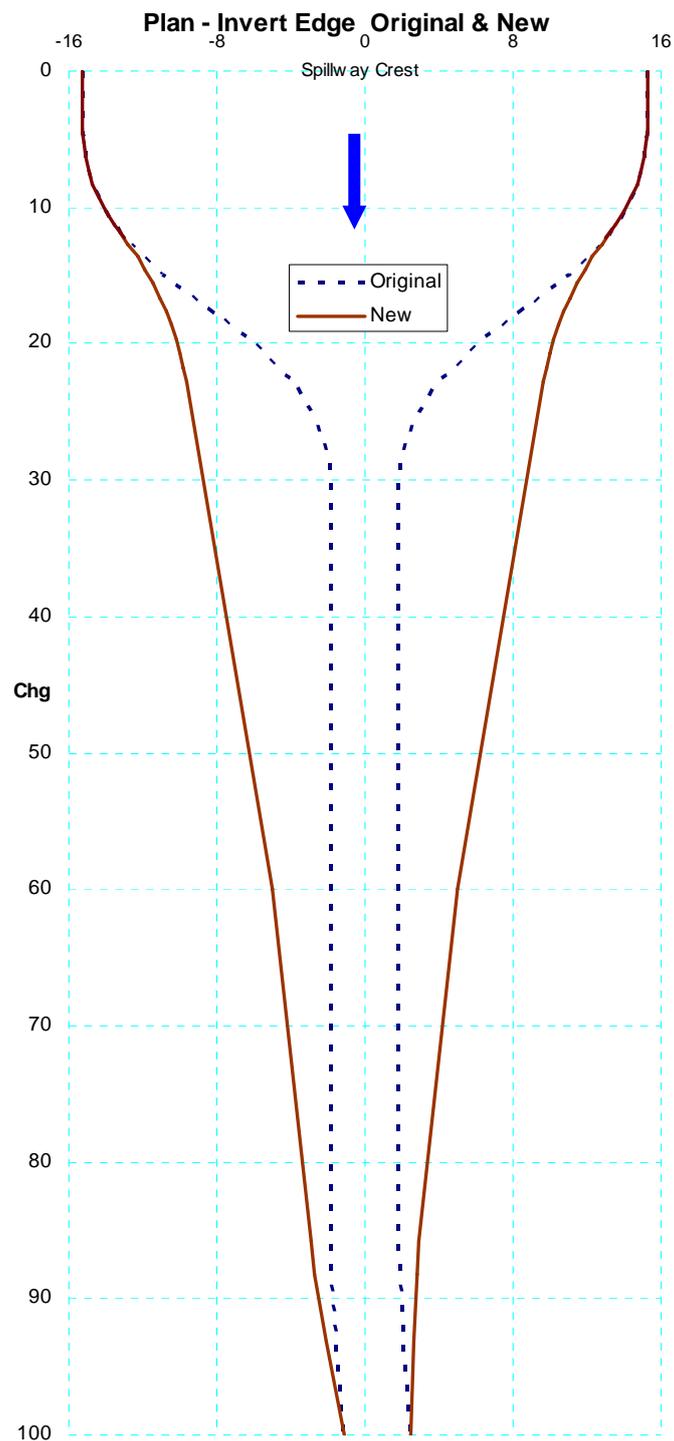
This diagram shows the change to the plan profile of the invert which has been made.

It was estimated that a flow of 40 cubic metres per second would begin to overtop the side walls where it reaches the base width of 3.66 metres. Three options were considered to remedy the problem; widen existing channel, new channel on right abutment and new auxiliary spillway on the saddle dam. The widening of the existing channel was chosen. The principal design criteria for the upgrade was for the spillway chute to contain the 0.1% AEP without overtopping. A significant challenge was flood control during construction as significant lowering of the reservoir was constrained by the need to maintain the city water supply. Analysis of several 100mm in 24 hour rainfall events indicated that the lowered reservoir could contain the resulting inflows

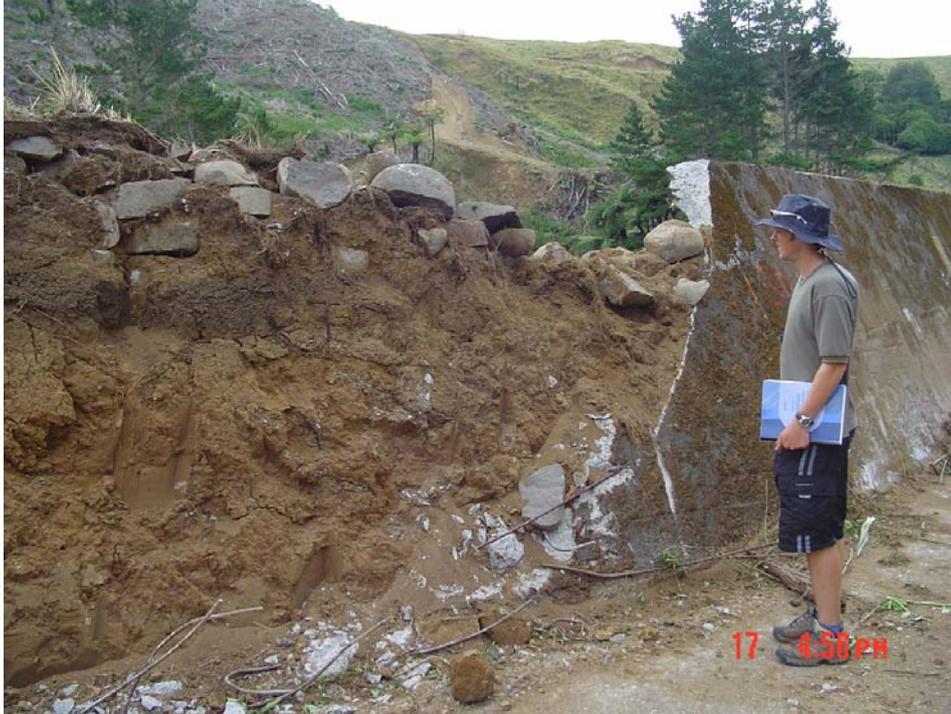
Photo 1 : Demolition of the existing sidewalls

It was interesting to see that the original lining where it was placed against fill had been poured against a dry stone wall which had been placed on the side of the fill. The bulk, 90%, of the sidewall was placed against excavated surfaces and the consistency of thickness was remarkable.

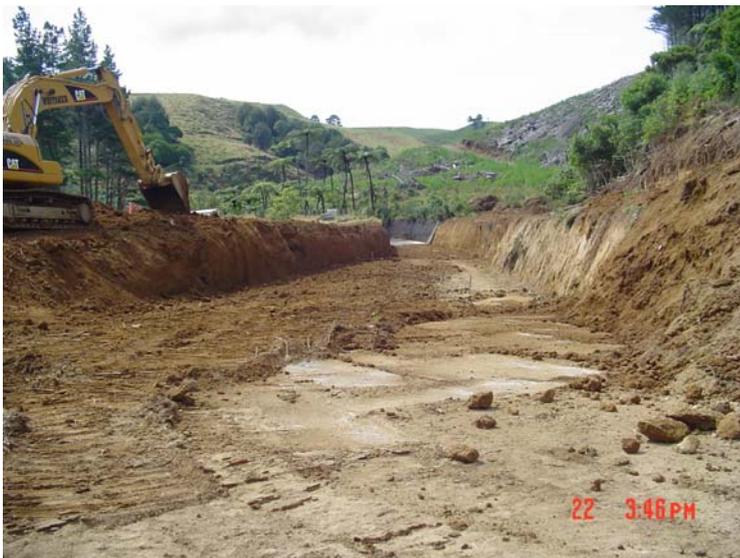
**Photo 2 :
Original Lining
removed.**

The ash material forming the foundations of the channel was, as predicted by the investigations dry and firm and no special areas of undercutting were required. In order to protect the invert from becoming too soft in the event of rain 50mm of undercut was replaced with drainage material.

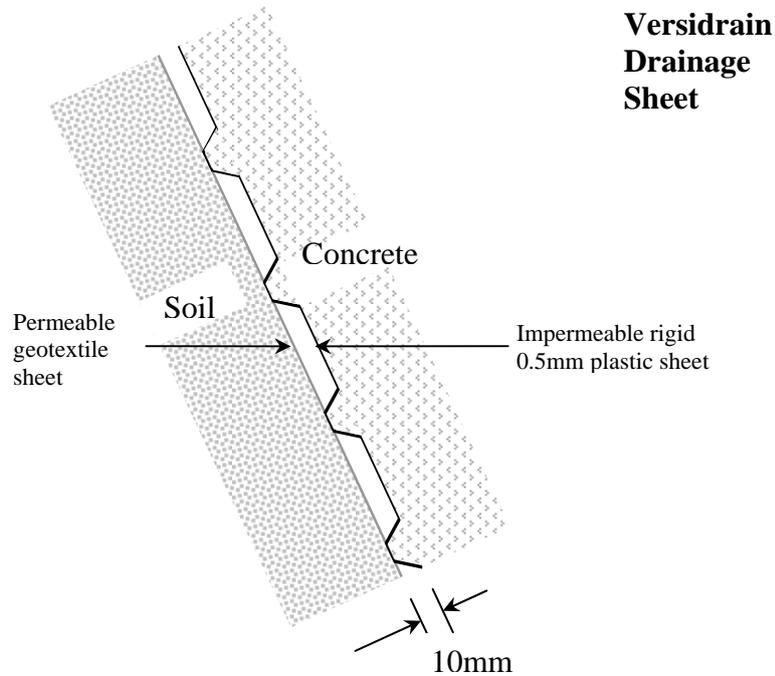
Due to the proximity of the true right side to the steep slope of the right abutment and the potential for uplift along the remainder of the channel it was decided to use a manufactured drainage layer against the sidewalls as shown below.

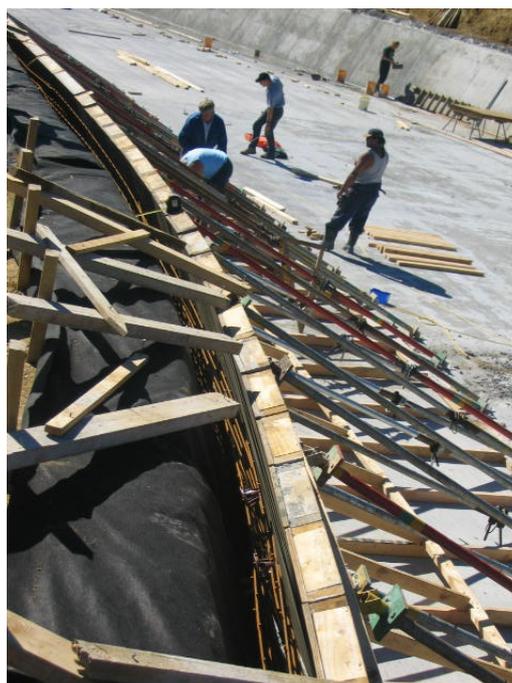
**Photo 3 : Curved
sidewall ready to
pour**

The shuttering for the side walls which are 2.4 metres long down the slope required some stiff bracing. The top edge and working surface was protected with a sheet of PVC. Perhaps Hessian would have been the material of choice back in 1930.

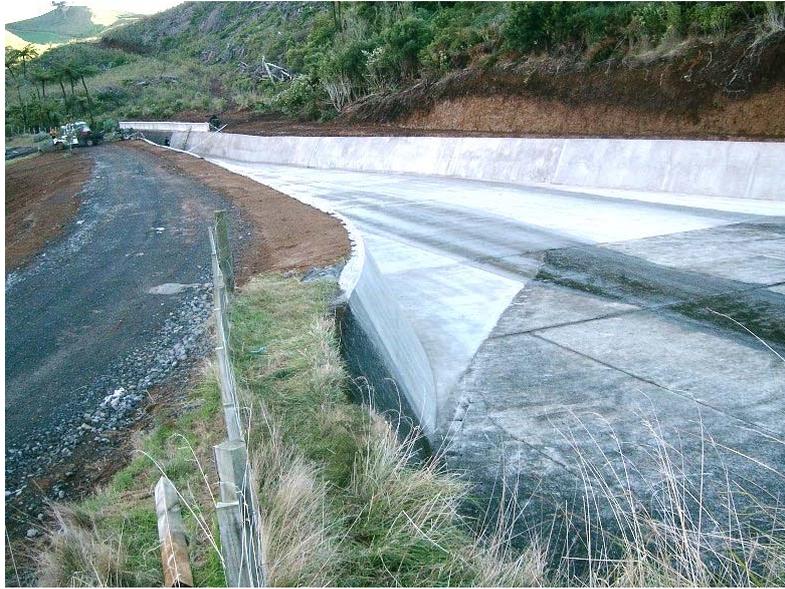
Photo 4 : Only grass planting and hydroseeding remaining

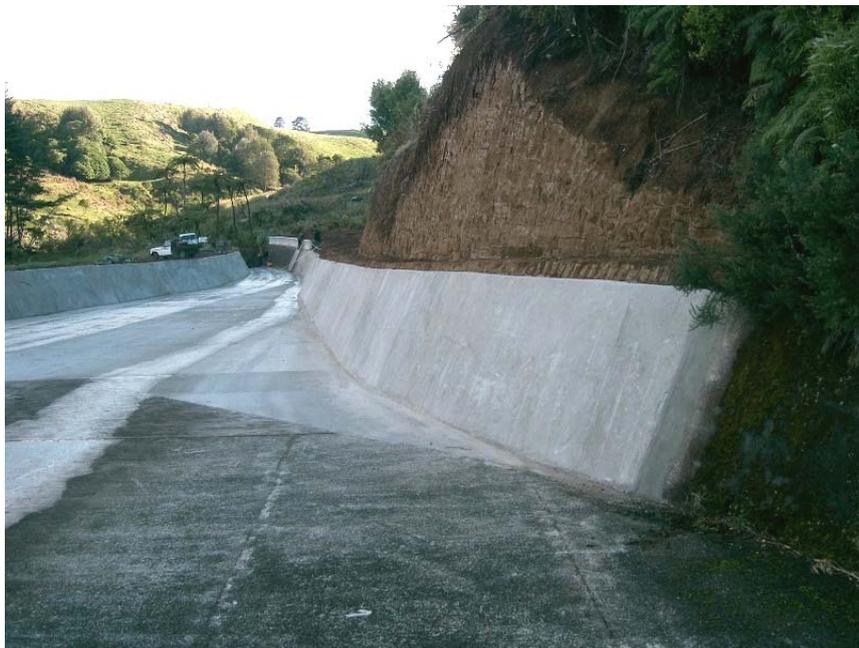
Photo 5 : True right side cut to be hydroseeded.

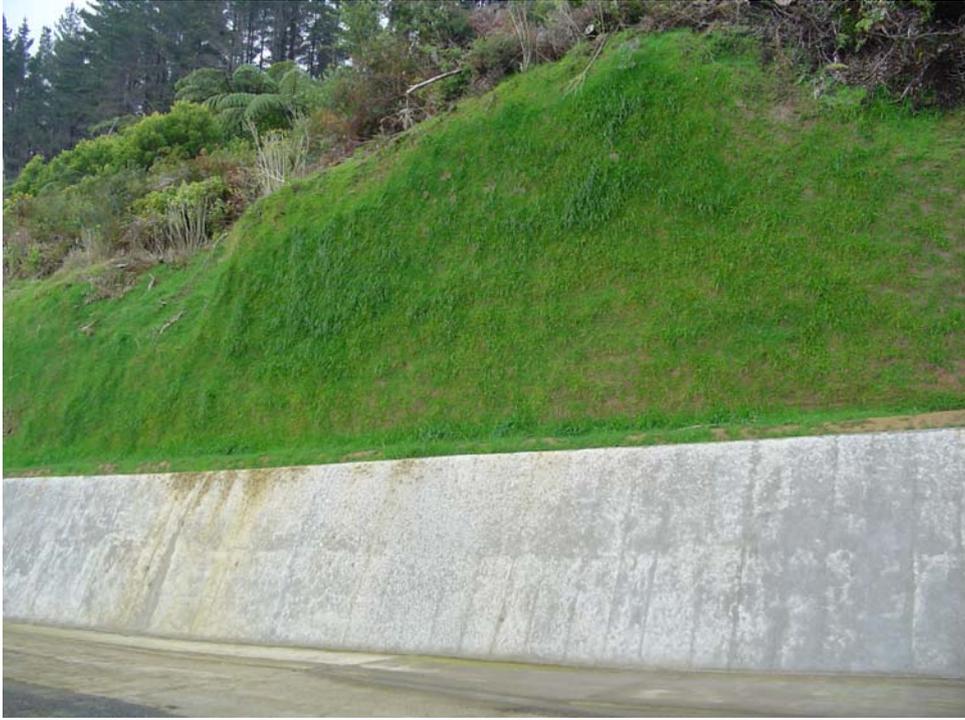
Photo 5 : True right side cut after hydroseeding.
