Slope failure in complex volcanic terrain, Opito Bay, New Zealand

S.L. Price

Riley Consultants Ltd, Auckland, New Zealand

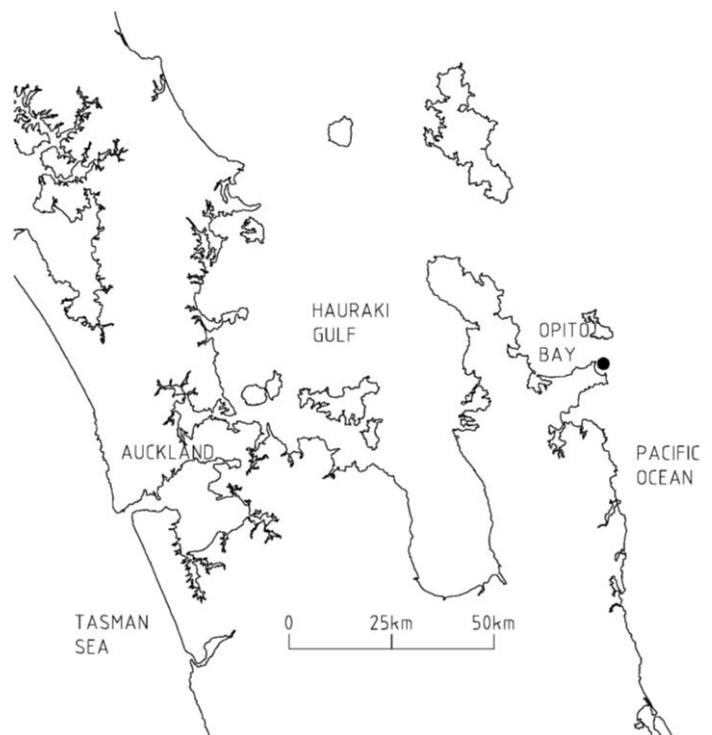
Figure 1

The Ohinau Drive slide is located at Opito Bay, north-eastern Coromandel Peninsula, New Zealand, as shown in Figure 1. The slope failure developed largely beneath vacant lots of a mid-1990s subdivision, extending southward into Tahanga Hill, as shown in Figure 2.
