# Cobb Dam sinkholes

Bruce Walpole <sup>1</sup> and Craig Scott <sup>2</sup>

<sup>1</sup> TrustPower Ltd, New Zealand

<sup>2</sup> Rileys Consultants Ltd, New Zealand

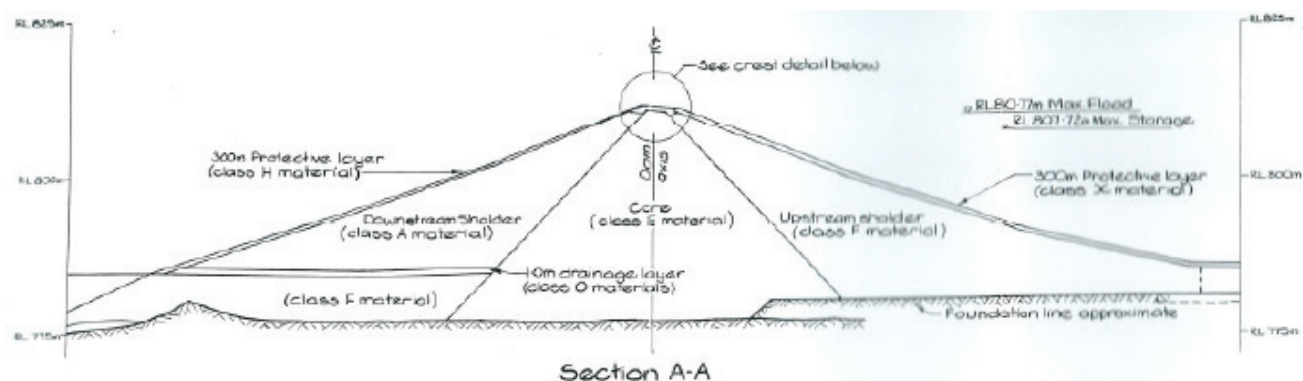
**Figure 3. Typical cross section of the embankment**

Cobb is a zoned earth and gravel embankment dam (Fig. 3) with a volume of 330,000 cubic metres. It is 34m high and 221m long. The reservoir volume when full is 30 million m<sup>3</sup>. The dam is a high potential impact category (PIC) structure.
