## Counterfort Drain Performance in the Auckland Area

S. M. Torvelainen<sup>1</sup>, GIPENZ, NZGS

<sup>1</sup>Riley Consultants Ltd, P.O. Box 100253 North Shore, Auckland 0745; PH (09) 489 787; email storvelainen@riley.co.nz

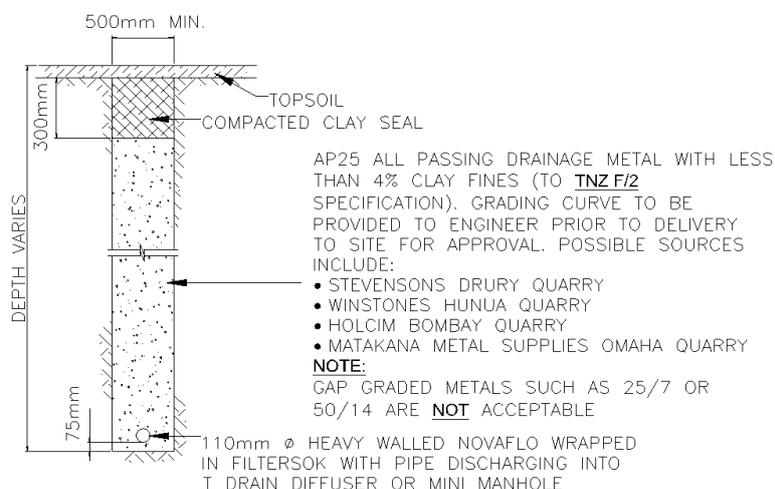
The typical detail of a counterfort drain, as specified by Riley Consultants Ltd (RILEY), has had very limited changes made to it over the last 25 years. Figure 1 shows the typical cross section through a counterfort drain as specified by RILEY currently.

Figure 1. Typical Counterfort Drain Detail 2016 (RILEY)

The main changes to the RILEY counterfort drain detail over time as compared to Fitch (1990) are that the 110mm diameter “Novaflo” (perforated plastic pipe) is specified as heavy wall and, although the filter material is similar in composition the scoria specification is no longer used. Instead a general all passing material to Transit New Zealand F2 specification is stipulated. The appropriate scoria material typically was sourced from Three Kings Quarry in Auckland. However, the output of this material from the quarry (in particular low fines content) has now ceased as the quarry is economically at the end of its life. It is important that the grading curve of the filter material is specified by the engineer and that of the acquired material is checked before the material is delivered to site. The criticality of the low fines content is often not understood by the contractor. From some quarries a blended material or a builder’s mix can produce a material similar to the F2 grading envelope.

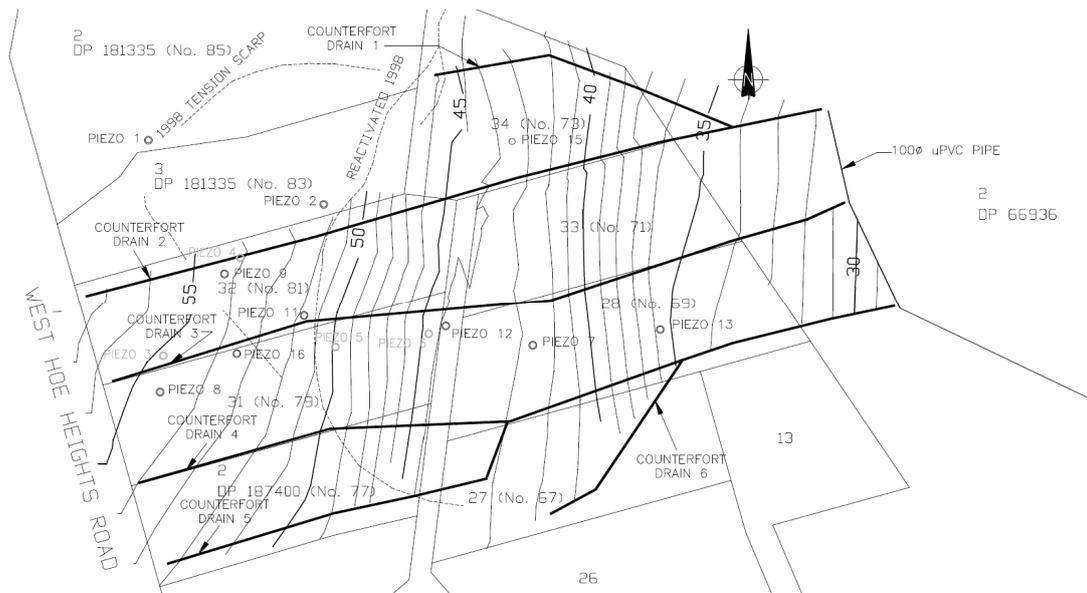
Figure 2. West Hoe Homes Site Plan

Review of a counterfort drain system designed by RILEY on land at 67 to 73 and 77 to 81 West Hoe Heights Road, Orewa (Figure 2) known as West Hoe Homes (WHH) site for which an extensive period (over 15 years) of groundwater monitoring has occurred post drain construction provides insight into how counterfort drains in the wider Auckland area perform, beyond Waitemata Group geology, and allows assessment of performance over time. The WHH site is located near the east coast in the northern Auckland Council area (formerly known as Rodney District). The Rodney District has areas underlain by Northland Allochthon (historically known as Onerahi Chaos Breccia). Toan (1980), on behalf of Beca, Carter, Hollings and Ferner, provided a summary of Northland Allochthon/ Onerahi Chaos Breccia. Toan outlines that the Northland Allochthon is irregularly bedded rocks found both below and above Waitemata Group material. Toan explains that there is often a cohesive, low permeability skin of residual mudstone or siltstone in the allochthon, particularly on gentle slopes and ridges. This is different to Waitemata Group residual clays; Fitch (1990) outlines will often have major seepage path in vertical shrinkage cracks or soil creep may also open tension cracks across the slope which have high permeability’s.

To improve site stability counterfort drains were installed on the site with layout and characteristics outlined shown in Figure 2 and Table 1 respectively. The groundwater levels in Table 3 indicate that the counterfort drains had a demonstrable effect on groundwater levels. Stability review of the slope from the groundwater levels recorded post construction to early 2003 indicated that under extreme levels the FOS of the slope was 1.30. Although the counterfort drainage system was primarily installed for land stabilisation purposes future development for residential dwellings was being considered. For this it would be necessary to prove that a FOS of 1.50 for the site had been attained. To clarify whether perched groundwater was potentially giving an exaggerated result of the hydrostatic pressure at failure plane level it was recommended that multiport piezometers be installed. Confirmation of such a phenomenon would indicate that the FOS in the land was higher than had been modelled under observed extreme groundwater.

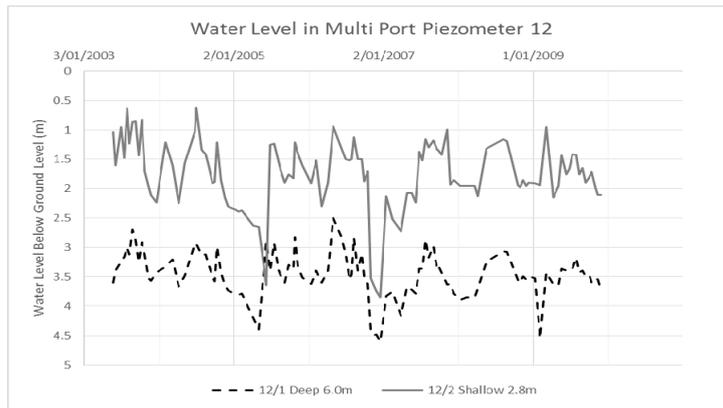
Figure 3. Multi Port Piezometer Performance

Four multiport piezometers were installed at the site; two in May 2003 (P12 and P13) and two in April 2004 (P14 and P15). Each piezometer had an upper screen from ground level to approximately 3.5 – 4.0m depth and a lower screen from below the depth of the shallow piezometer to the base of the drilled boreholes which were 6m deep. Figure 3 shows results from multiport piezometer 12 (over time period where both shallow and deep parts of the piezometers remained operational) clearly show that a downward groundwater gradient does exist at the site and hydrostatic pressure at the inferred failure surface level is less than indicated by a standpipe piezometer without a targeted response zone and may reflect a separate aquifer, a downward gradient in flow or a combination of both.

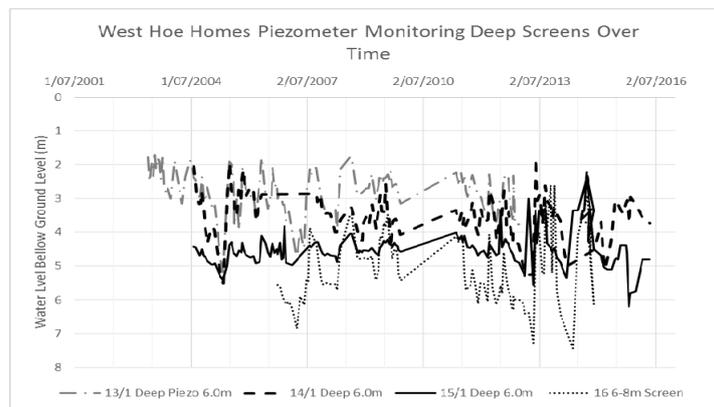
Figure 4. Ground water levels of deep screen piezometers over time

A selection of deep screen piezometers currently still in operation on site is shown in Figure 4 to assess the performance of counterfort drains on hydrostatic pressure at the depth of the inferred failure surface. No obvious trend is shown in these groundwater levels from when monitoring commenced that would indicate that the groundwater levels have risen over time. There does however appear to be some increased activity with P15/1 Deep and P16 over 2013 and winter spring 2014. However, peak groundwater levels for these piezometers coincided with their lowest recorded levels in the same period. For this period the rainfall does not follow any atypical trend. Observations on site, such as of concrete driveways and kerbings do not indicate any ground movement, however, an up to date survey of monitoring points has not recently been undertaken.
