## **Anzac Cliffs –Geotechnical aspects of cliff stabilisation works**

S R Orgias  
Riley Consultants Ltd, NZ  
sorgias@riley.co.nz (Corresponding author)

Keywords: Anzac Cliffs, slope stabilisation, fill buttress

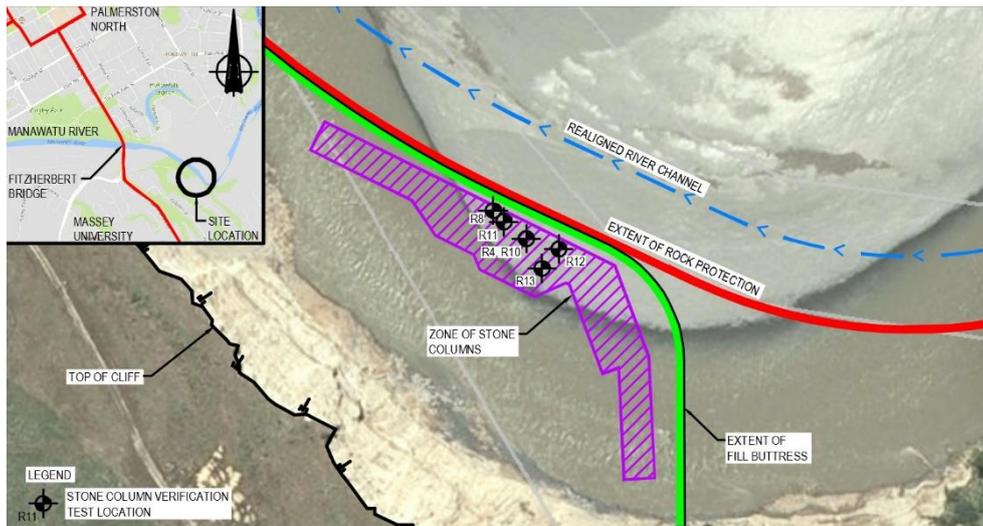
**Figure 1: Location of machine holes for stone column verification testing, extent of stone columns, erosion protection and stabilisation works (additional borehole and test pit locations omitted for clarity)**

The proposed Anzac Cliff residential subdivision is sited above the southern true left bank of the Manawatu River, some 3.5km south-east of Palmerston North City Centre (Figure 1). The north-eastern portion of the subdivision was bound by an approximately 50m high cliff that was subject to large-scale ongoing river erosion. The rapid erosion of this section of the cliff became a concern to various stakeholders with regard to the additional sediment load it added to the river, and the potential adverse effects that its altered course would have on the existing river protection works on the opposite northern bank. In April 2006 works to realign this section of the river back to its 1992 course were incorporated into the City Reach Project, a major works programme to upgrade the lower Manawatu River Scheme that protects Palmerston North from flooding.

Modelling of the required ground improvement work was carried out utilising selected parameters and the slope computer program Slide, to meet the project criteria of no more than 500mm deformation in a 0.43g maximum design earthquake (MDE). The residual shear strengths for potentially liquefiable layers were selected based on correlations with SPT testing (Idriss and Boulanger 2008). Analysis indicating an 8m to 18m width of stone column treatment for different fill buttress heights could achieve the requirements of a static post liquefaction FoS of 1.2, from a FoS of less than 1.0 without stone columns. The finalised geometry of the stone column layout is based on these calculations, with extrapolation based on judgement. The design utilised a 15% replacement value of imported crushed gravels for the columns (Figures 1 and 4).

Further validation testing consisting of boreholes with SPT testing was carried out following installation of the columns with very significant strength improvements were recorded (Figures 1 and 5). As expected, there was a variability in the strength improvements, which is considered to be related to variability in material type, with the best response noted in the clean sands and gravels, and lesser improvements in silty sands. Figure 5 shows the calculated FoS of 1 against liquefaction based on correlations between relative density and liquefaction trigger values (Boulanger & Idriss, 2014). Due to the nature of the materials and significant scatter for the SPT results, the liquefiable layer was characterised based on the 66 percentile (i.e. 66% of values are greater than the design value) (Idriss and Boulanger, 2008).

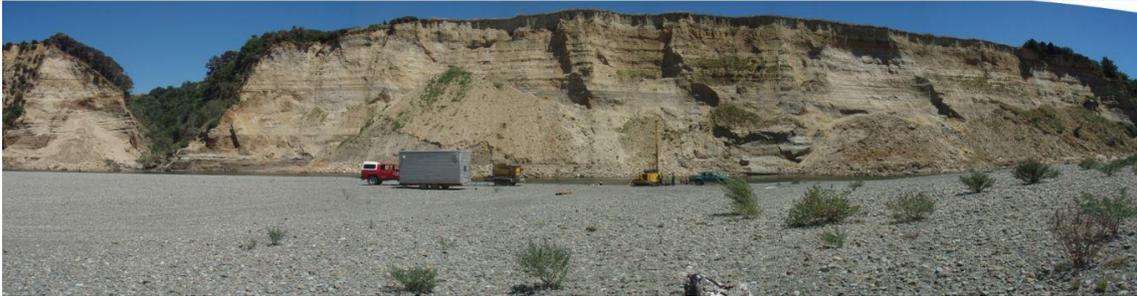
**Figure 2: Composite of photographs taken from the opposite true right northern river bank during 2008 feasibility study**

The initial feasibility study project undertaken by RILEY in 2007 was based on our knowledge of the area, visual assessment of the site and adjacent areas, and a review of available nearby subsurface information. The site had the advantage that the cliff materials were well-exposed over the majority of the cliff face (Figure 2). Subsurface investigation works at the base of the cliff were limited by access constraints to the gravel banks on the opposite side of the river to the cliff. In January 2008 two machine holes were drilled on the gravel banks adjacent to the true right northern side of the river, with a further two holes drilled along the gravel banks in August 2012 (Figure 2) in order to identify any constraints with respect to foundations of the proposed large fill buttress supporting the reshaped cliff.

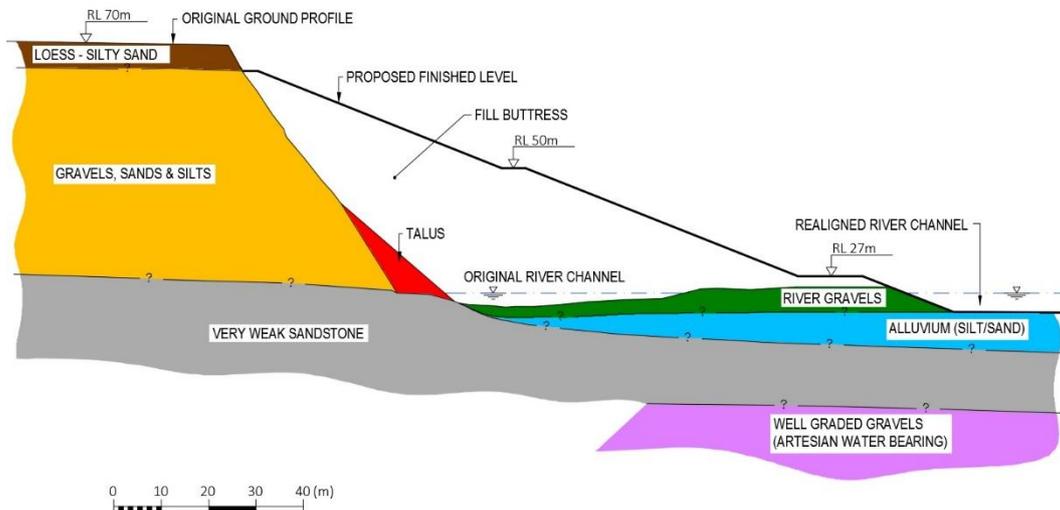
**Figure 3: Simplified geological cross section showing original and finished ground profiles**

The Anzac Cliffs, along with the adjacent Waicola and Strand Cliffs, have formed as a result of down cutting of the Manawatu River into a coastal terrace formed during the previous interglacial period around 100,000 years ago (Lee & Begg 2002). These sand, silt, and interbedded sandy gravel horizons were visible in the cliff face and capped by loess. At the base of the cliff an erosion-resistant rock platform, interpreted to be of Pliocene Age, was exposed. The sandstone horizon is very weak in engineering terms, but is considered more erosion-resistant than the cliff materials above (Figure 3).

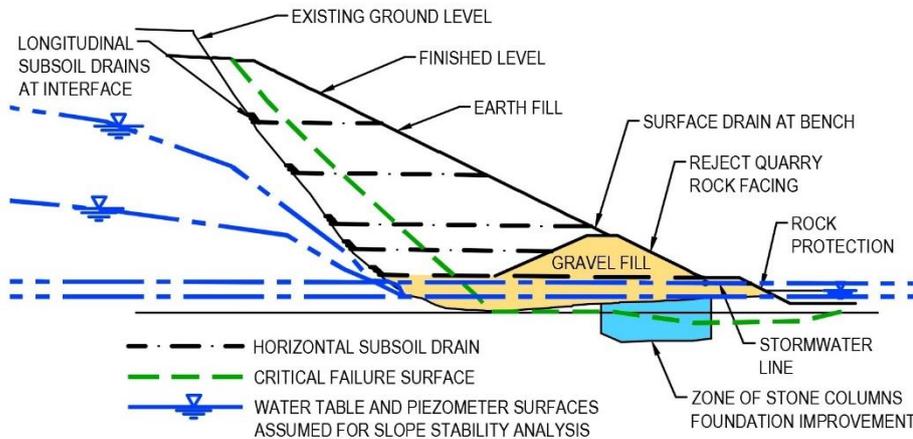
**Figure 4: Cross section showing zone of stone columns, subsurface drainage, groundwater levels assumed for analysis, and critical failure surface from slope stability analysis**

drainage. The more potentially hazardous location was assessed to be within the foundations of the fill buttress. Loss of support here due to widespread liquefaction could lead to large-scale lateral spreading, gross settlement and, in extreme cases, excess lateral movement of the entire cliff. Slope stability analysis was utilised for design of the fill slopes; this included an assessment and identification of where stability was assessed to be marginal below the buttress toe (Figure 4).

Shallow-seated slumps were observed to occur on these steep cliff slopes where concentrations of surface water occurred. Surface collector drains were installed at the intermediate bench with a piped outlet to the cliff base (Figures 4 and 9). The reshaped slope is proposed to be vegetated to minimise surface water infiltration in the long term and also bind the surficial soils, reducing the risk of rill erosion on the face. To monitor the performance of the fill slope, a series of survey points were set up that are subject to ongoing monitoring for horizontal and vertical movement. To date the slope's overall performance is within expectations (Figure 9).

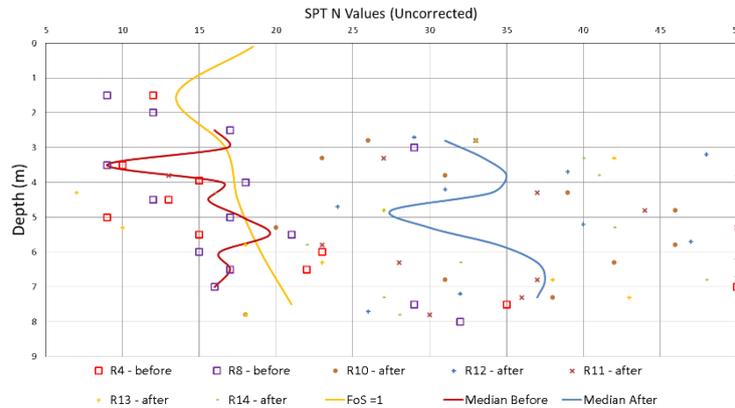
**Figure 5: SPT N tests from boreholes measured before (plotted as squares), and after installation of stone columns installation (liquefaction trigger values (FoS=1), and median before and after SPT N lines shown)**

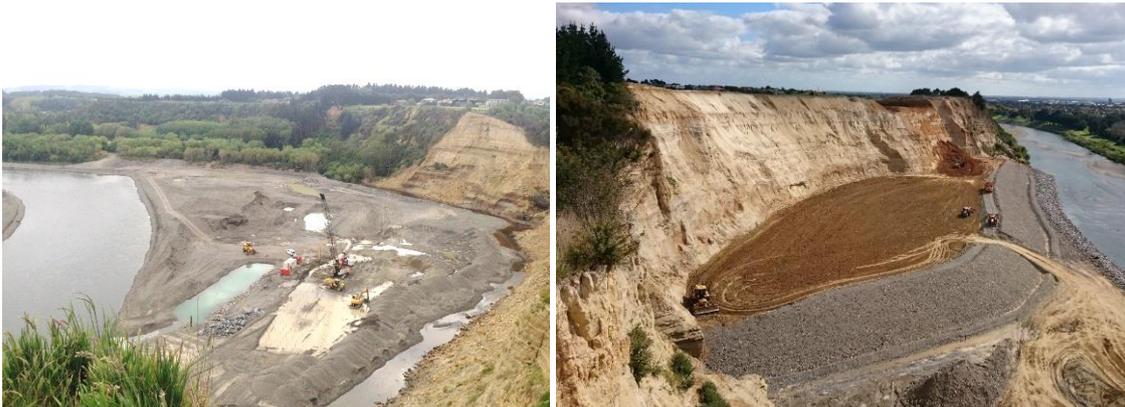
**Figure 6: Looking south towards stone column installation, (9 December 2014)**

**Figure 7: Looking north towards later filling operations (20 April 2016)**

The second stage of stone column installation commenced in December 2014 following works to divert the river (Figure 6). This involved the installation of a 3,899m total length of stone columns, with individual columns varying between 6.3m and 7.3m depth. River levels were a constant ongoing threat to progress, with a flood on 10 December raising water level about 2m

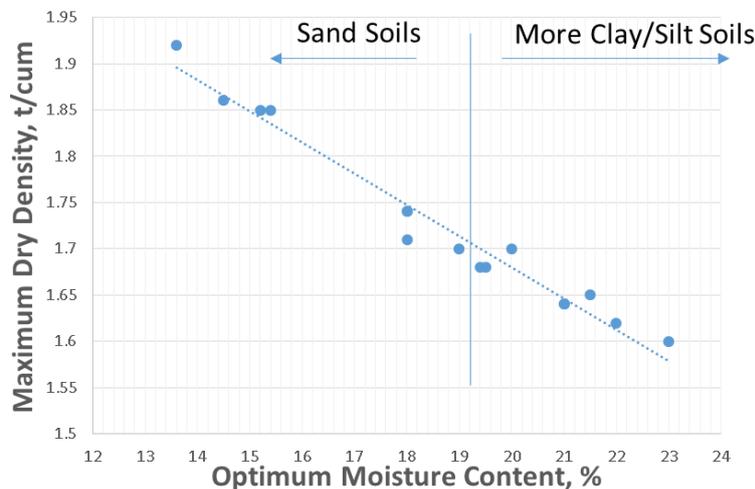
**Figure 8: Range of maximum dry density vs optimum moisture content for buttress fill from laboratory proctor tests**

The variability of material encountered in the cliff meant that compaction test results needed to be closely monitored and testing criteria adjusted to reflect the materials. To ensure fill materials achieved the design criteria, ongoing standard compaction proctor tests to determine maximum dry density, were compared to materials tested in the field. Field tests consisted of Scala penetrometer, shear vane, and nuclear density meter (NDM) with oven-measured water contents. Testing of materials on the same site ranging from clay to sand highlighted the importance of selecting the correct targets for dry density, and field tests for different materials. The more sandy soils have typically shown a higher maximum dry density with a lower optimum water content, and the opposite for more clayey soils (Figure 8). Monitoring involved an ongoing review of field and laboratory test data and regular site visits, including documentation of fill material and ground conditions. Information and feedback shared between the laboratory, consultant, and contractor was required to ensure varying materials were conditioned to an acceptable water content.

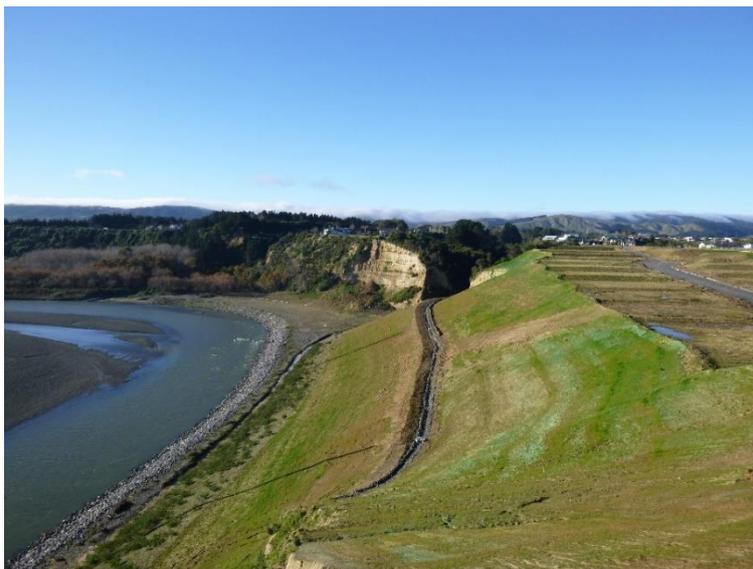
**Figure 9: Photograph of completed realignment and cliff stabilisation works**
